# FACILITY CONDITION ASSESSMENT

## MANHATTAN BEACH PRESCHOOL

**EMG Project #:** 112851.15R-001.017

**Date of Report:** April 20, 2015

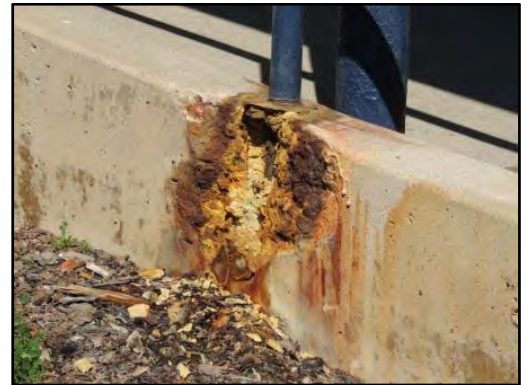
Reinforced concrete retaining walls are located at grade changes throughout the site. Painted metal railings as well as chain link fence are mounted on top of the retaining walls.

- The topography and adjacent uses do not appear to present conditions detrimental to the property.
- The landscape materials are in good condition and will require routine maintenance during the assessment period.
- The underground irrigation system appears to be in good working order. According to the POC, replacement of the sprinkler system will be required during the assessment period. The cost of this work is included in the Replacement Reserves Report.
- The retaining walls are in fair to poor condition. The cost of a retaining wall study has been included. See Section 1.2.

- The retaining walls are in fair to poor condition. A professional engineer must be retained to analyze the existing condition, provide recommendations and, if necessary, estimate the scope and cost of any required repairs. The cost to retain an engineer is included in the Replacement Reserves Report. The cost for any possible subsequent repairs is not included in the cost tables.

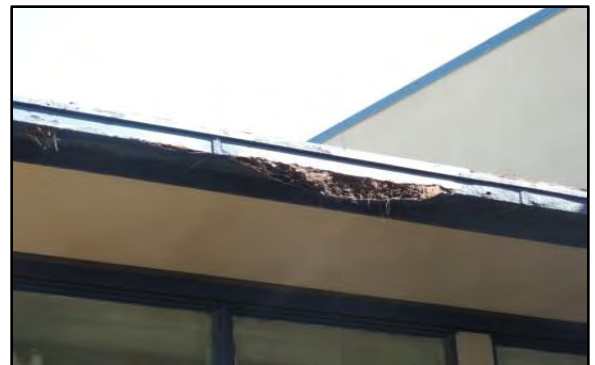
- The property does not have a dedicated roof repair and maintenance contractor. On-site personnel maintain the roofs or a contractor is retained when required.

- According to the owner's representative, the roof finishes are approximately 25 years old and has no warranty.
- The roof membranes are in fair to poor condition. Based on their estimated Remaining Useful Life (RUL), the roof membranes will require replacement during the assessment period. The cost of this work is included in the Replacement Reserves Report.

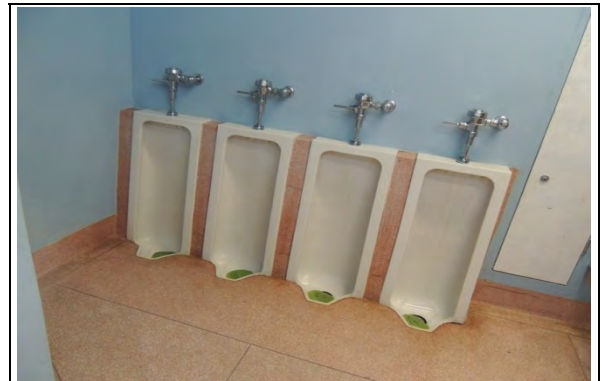
- The water and sewage piping is in poor condition; per facilities personnel, there are constant water clogs and leaks due to deteriorating water and sewage pipes. The water and sewage pipes will need to be replaced. The cost for this work is included in the Short Term Cost Report.
- The water pressure appears to be adequate.
- There is no evidence that the property uses polybutylene piping for the domestic water distribution system.
- The accessories and fixtures in the restrooms are in fair condition. Based on their estimated Remaining Useful Life (RUL), replacement is recommended during the reserve term. The estimated cost for this work is included in the Replacement Reserves Report.

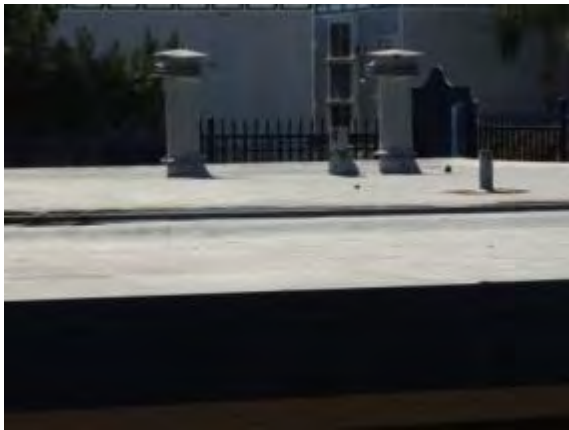
Photo #9:	Roofing
-----------	---------

- According to the owner's representative, there are active roof leaks primarily isolated to the covered walkways, modular buildings, and a few classrooms. The cost of this work is included in the Immediate Repairs Report.

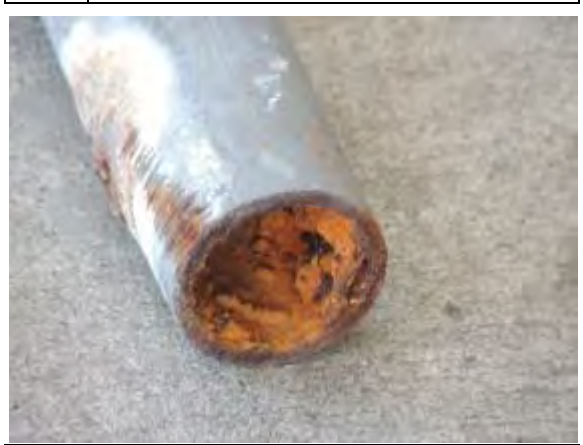
Photo #48: Deteriorating water pipe
