FACILITY CONDITION ASSESSMENT

FACILITY CONDITION ASSESSMENT of

GRAND VIEW ELEMENTARY

EMG Project #: 112851.15R-004.017
Date of Report: April 13, 2015
On site Date: February 17, 2015

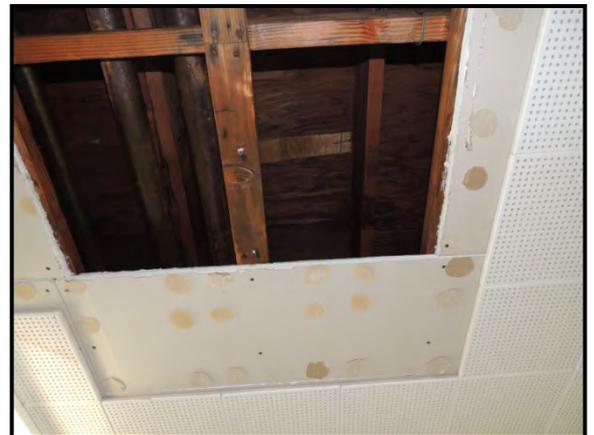
- The superstructure is exposed in some locations, which allows for limited observation. Walls and floors appear to be plumb, level, and stable. There are significant signs of ongoing and or past water intrusion into several areas of the property. See Section 1.2
- Per the owner's representative, all buildings have isolated evidence of wood framing deterioration due to insect and several have been serviced. See Section 1.2.

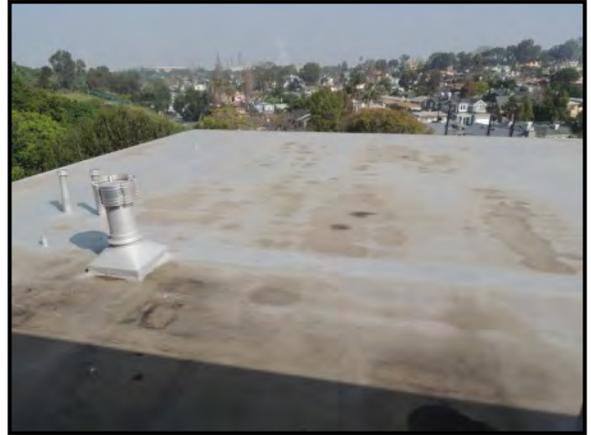
- At both campuses, the roof flashings are in fair to poor condition and should be replaced as part of the overall roof replacement. The cost of this work is included in the Replacement Reserves Report.

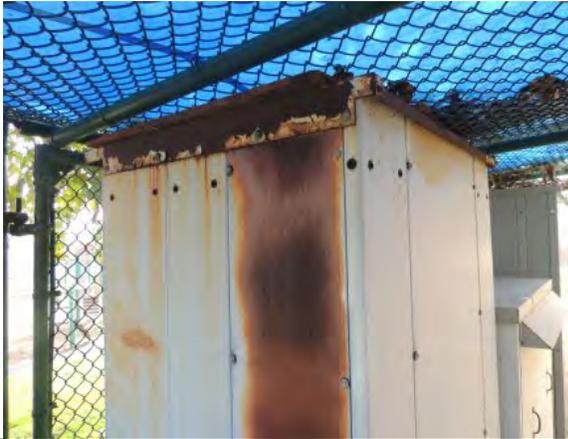
Photo #55: Deterioration at electrical panel enclosure

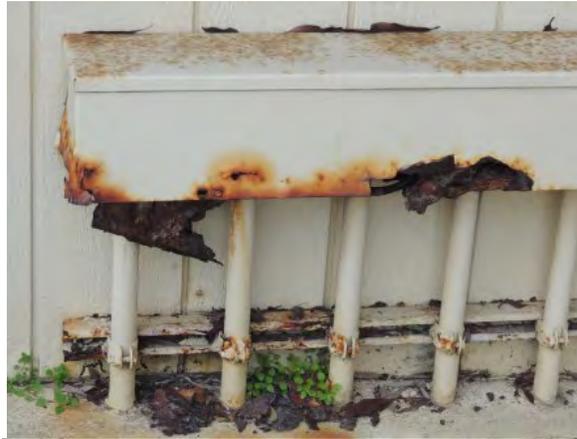
Photo #56: Deterioration at exterior electrical enclosure

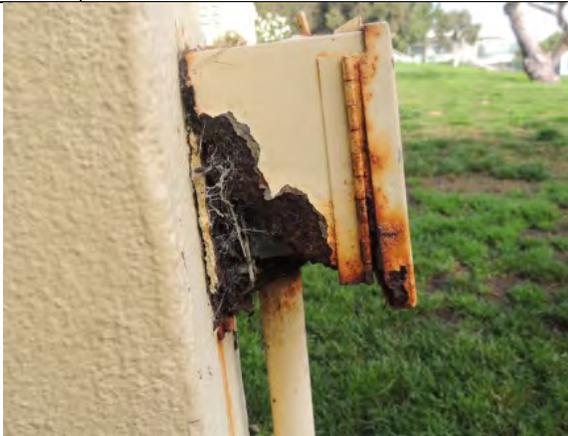
Photo #57: Deterioration at exterior receptacle enclosure

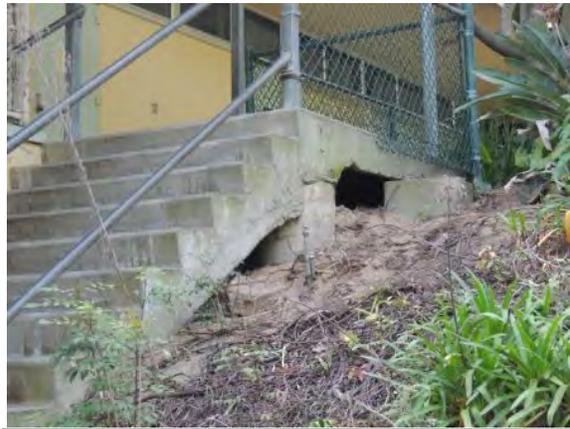
Photo #8:	Area where dirt has been washed out under stair system
-----------	--

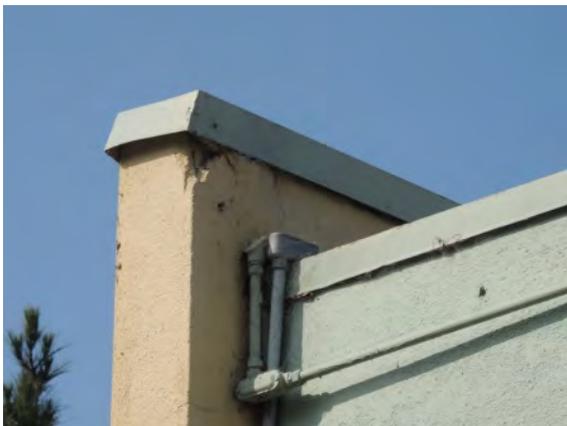
Photo #11:	Deteriorating exterior wall
------------	-----------------------------

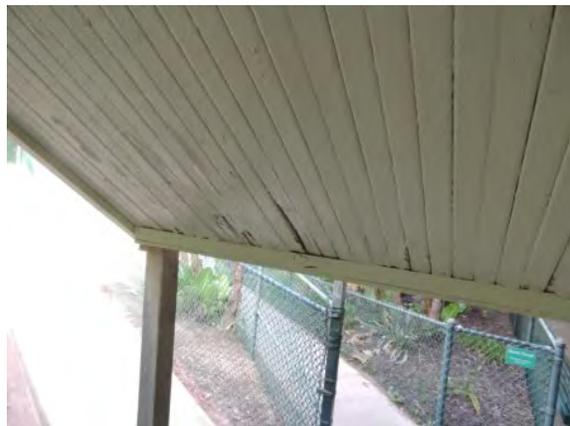
Photo #12:	Deteriorating covered walkway
------------	-------------------------------

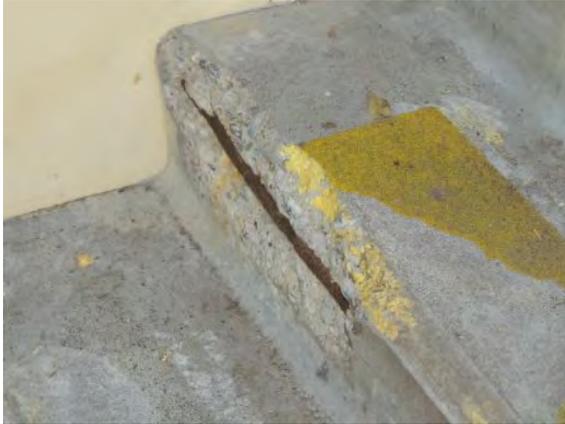
Photo #13:	Deteriorating steps
------------	---------------------

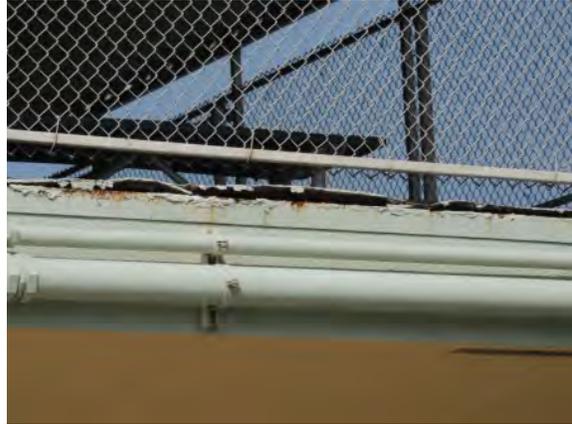
Photo #14:	Deteriorating decking edge
------------	----------------------------

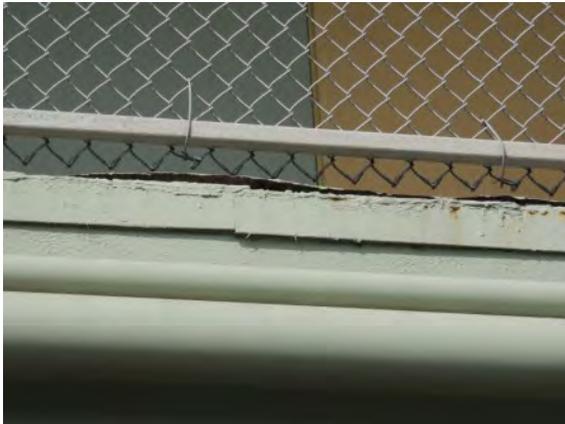
Photo #15:	Deteriorating decking edge
------------	----------------------------

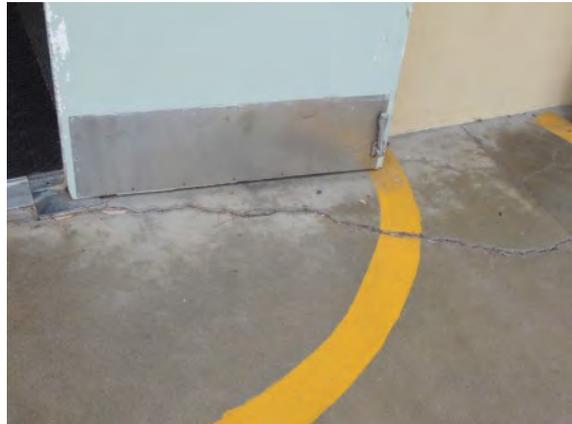
Photo #16:	Deteriorating floor slab
------------	--------------------------

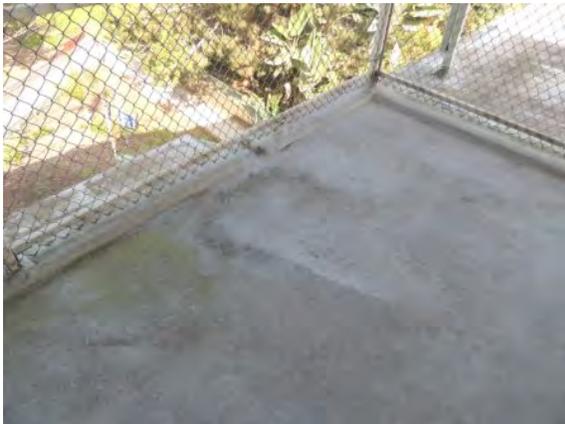
Photo #17:	Deteriorating floor slab
------------	--------------------------

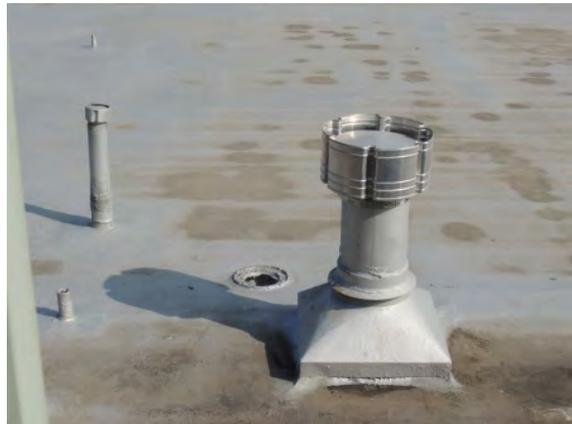
Photo #18:	Missing roof drain cover
------------	--------------------------

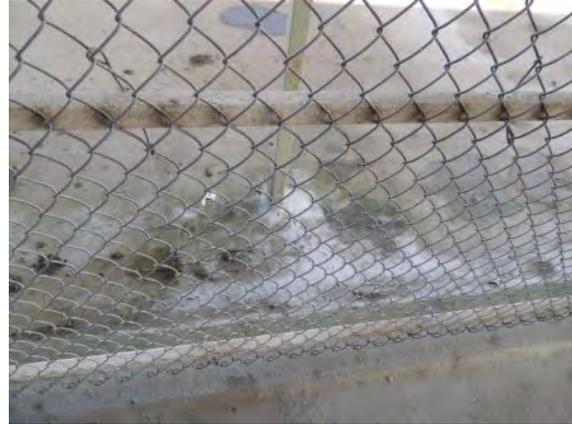
Photo #20:	Deteriorating roofing
------------	-----------------------

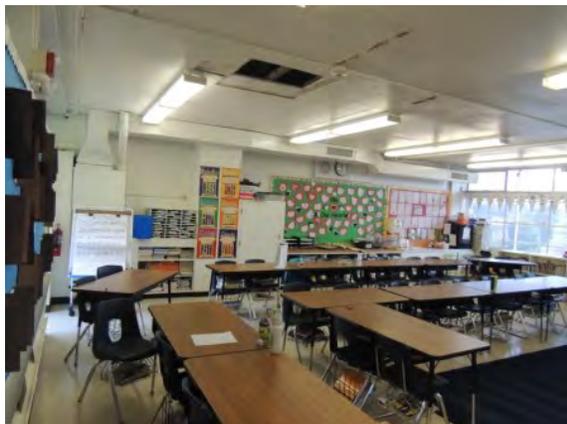
Photo #23:	Ongoing classroom roof leak
------------	-----------------------------

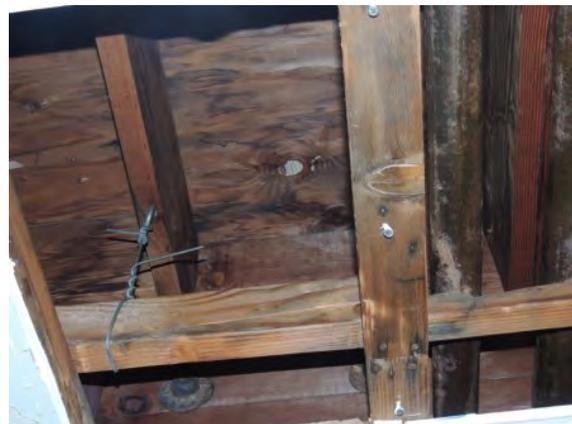
Photo #24:	Ongoing classroom roof leak
------------	-----------------------------

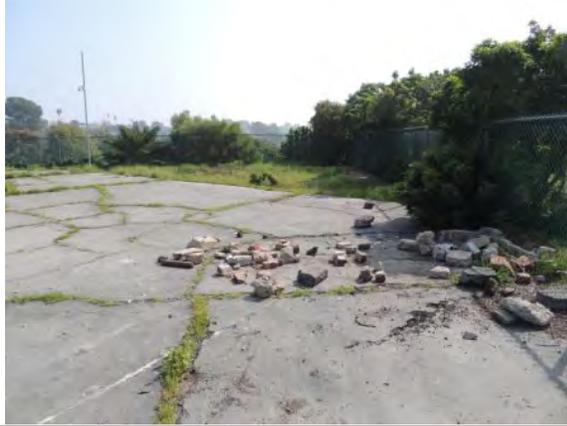
Photo #31: Deteriorating playground area
