FACILITY CONDITION ASSESSMENT

PENNEKAMP ELEMENTARY

EMG Project #: 112851.15R-005.017

Date of Report: April 7, 2015

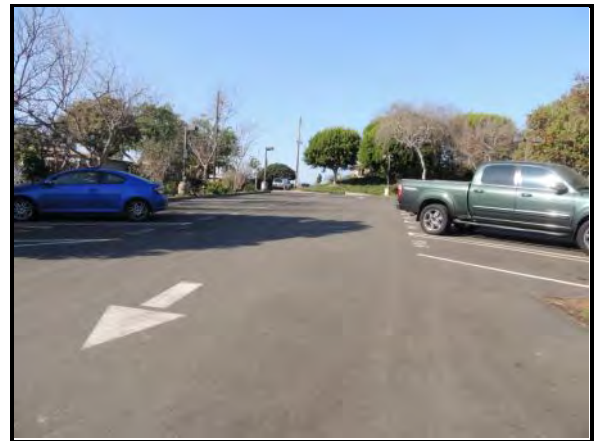
- The property does not have a dedicated paving repair and maintenance contractor. On site personnel maintain the paving and flatwork or a contractor is retained when required.

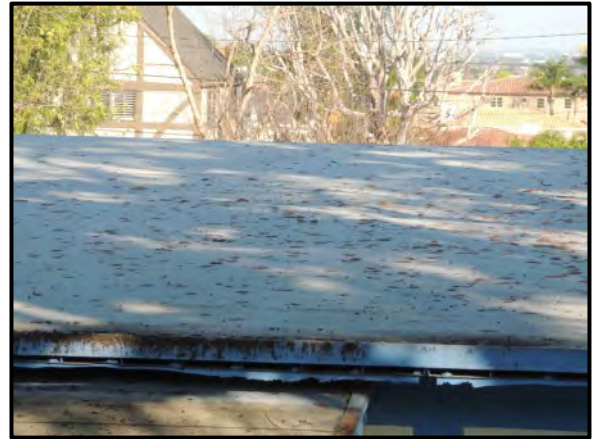
- The property does not have a dedicated roof repair and maintenance contractor. On site personnel maintain the roofs or a contractor is retained when required.

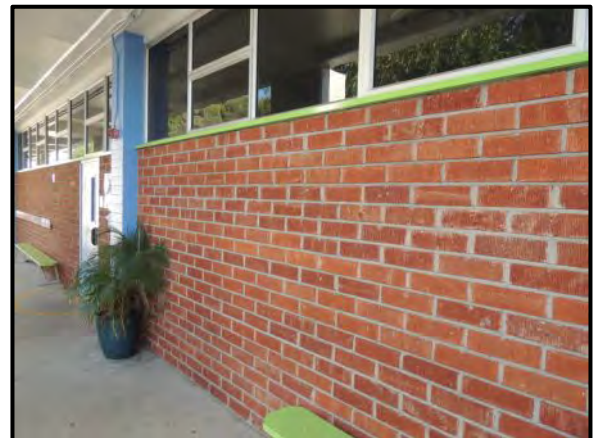
- The exterior finishes are in good condition. Painting and patching will be required during the assessment period. The cost of this work is included in the Replacement Reserves Report.

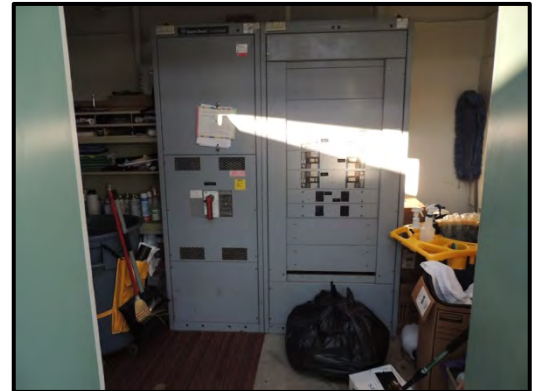
- The on site electrical systems up to the meter are owned and maintained by the respective utility company.
- The electrical service and capacity appear to be adequate for the property's demands.
- The switchgear, circuit breaker panels, and electrical meters appear to be in good condition and will require routine maintenance during the assessment period.

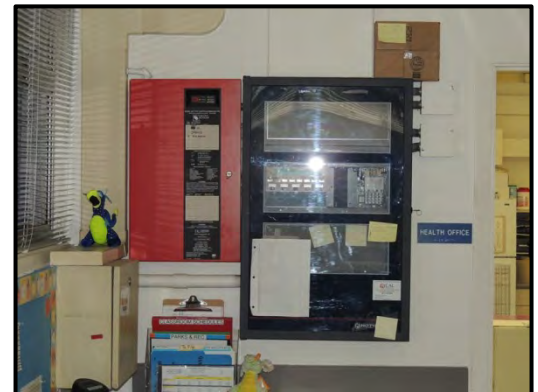
- Information regarding fire department inspections is included in Section 3.1.
- The pull stations and alarm horns appear to be in good condition and will require routine maintenance during the assessment period.

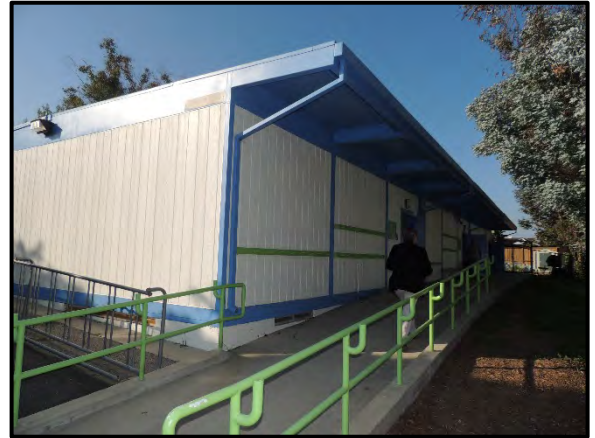
- The modular classrooms are in fair to poor condition, the roofing and siding are exhibiting signs of deterioration. The cost of this work is included in the Immediate Reserves Report.
- The maintenance and storage sheds are in good to fair condition and will require routine maintenance during the assessment period.
