FACILITY CONDITION ASSESSMENT

MIRA COSTA HIGH SCHOOL

1401 Artesia Boulevard

EMG Project #: 112851.15R-008.017

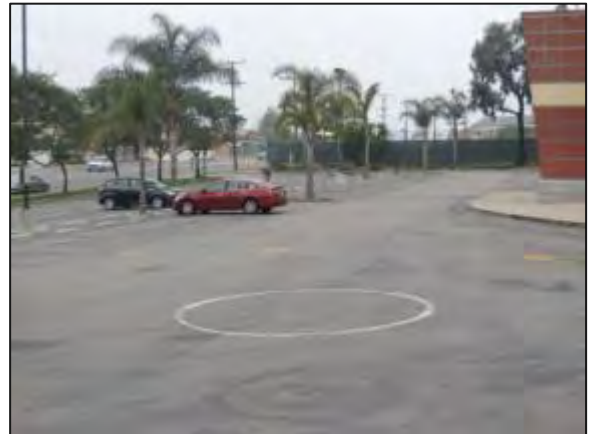
- The property does not have a dedicated paving repair and maintenance contractor. On site personnel maintain the paving and flatwork or a contractor is retained when required.

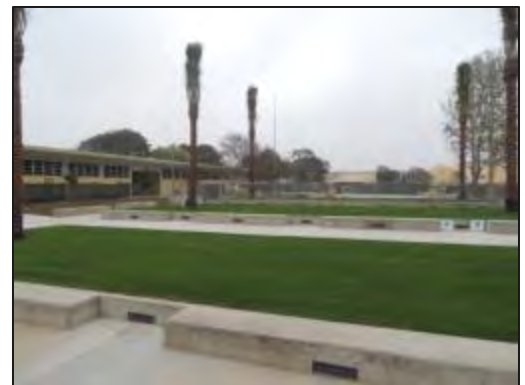
- The topography and adjacent uses do not appear to present conditions detrimental to the property.
- The landscape materials are in good condition and will require routine maintenance during the assessment period.
- The underground irrigation system appears to be in good working order. Replacement of sprinkler heads and minor repairs will be required during the assessment period. This work is considered to be routine maintenance.
- The retaining walls are in good condition. Routine maintenance will be required during the assessment period.

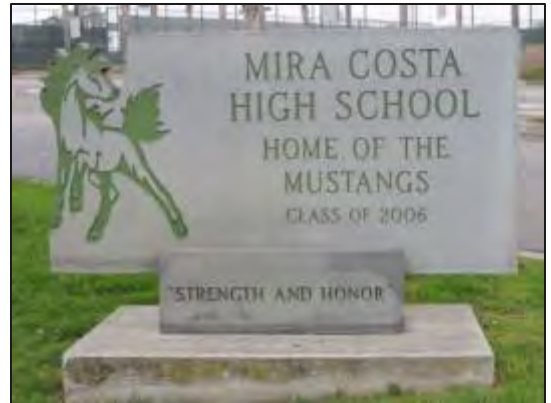
- The property and tenant identification signs are in good condition. Routine maintenance will be required during the assessment period.
- The exterior site and building light fixtures are in good condition. Routine maintenance will be required during the assessment period.
- The site fencing is in good condition and will require routine maintenance during the assessment period. Painting is considered to be routine maintenance.
- The dumpsters are owned and maintained by the refuse contractor.

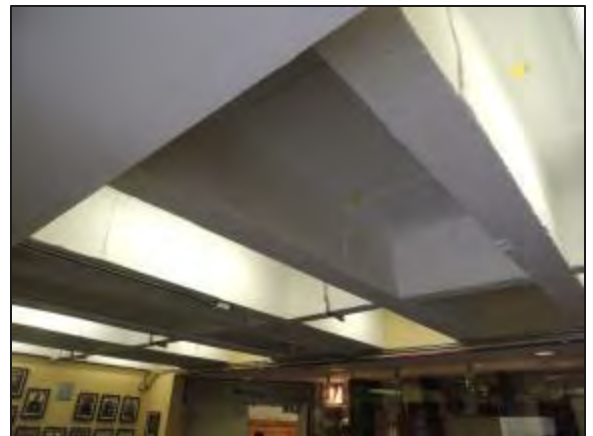
- The superstructure is exposed in some locations, which allows for limited observation. Walls and floors appear to be plumb, level, and stable. There are no significant signs of deflection or movement.

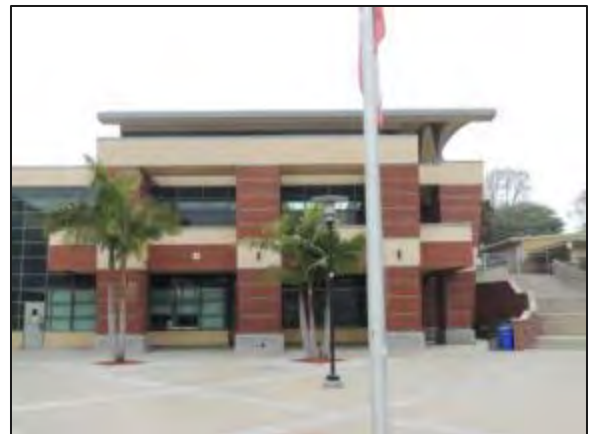
- The exterior finishes are in good to fair condition. Painting and patching will be required during the assessment period. The cost of this work is included in the Replacement Reserves Report.

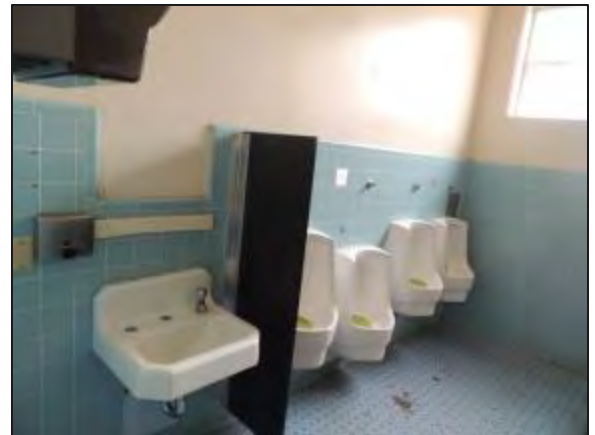
- The water and sewage piping is in fair condition. These systems will require routine maintenance.
- The water pressure appears to be adequate.
- There is no evidence that the property uses polybutylene piping for the domestic water distribution system.
- The accessories and fixtures in the restrooms are in good condition. These components will require routine maintenance.

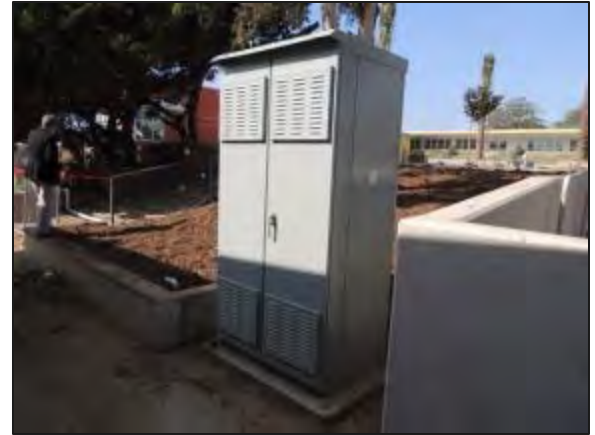
- The on site electrical systems up to the meter are owned and maintained by the respective utility company.
- The electrical service and capacity appear to be adequate for the property's demands.
- The switchgear, circuit breaker panels, and electrical meters appear to be in good condition and will require routine maintenance during the assessment period.
- The smaller stepdown transformers and associated electrical panels are in fair condition. Based on their estimated Remaining Useful Life (RUL), replacement is recommended during the reserve term. The estimated cost for this work is included in the Replacement Reserves Report.

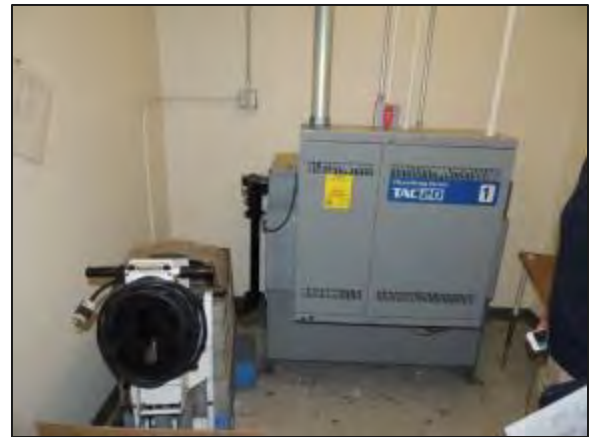
- The elevators are serviced on a routine basis. The elevator machinery and controls are the originally installed system.
- The elevators appear to provide adequate service. Based on its estimated Remaining Useful Life (RUL), the elevator equipment will require replacement during the assessment period. The cost of this work is included in the Replacement Reserves Report.
- The elevators are inspected on an annual basis by the municipality, and a certificate of inspection is displayed in the elevator cabs. The inspection certificate has expired. It is common for inspections to occur behind schedule. A new inspection should be scheduled as soon as possible.

3.2	Elevator	329314	D1011 Add ADA raised markings at elevator control panel, jams and hall buttons	0	0	0	1	Floor	\$6,350.00	\$6,350	\$6,350																					\$6,350

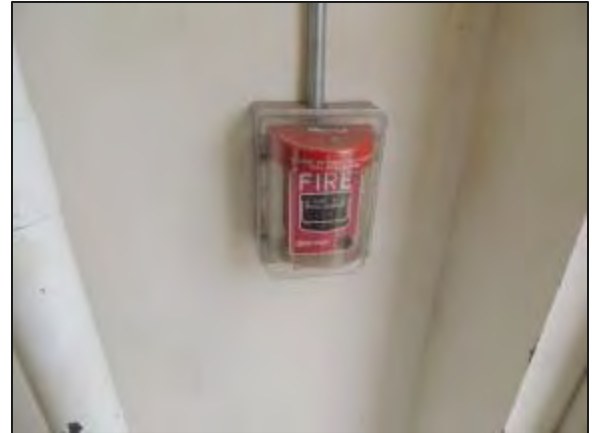
- Information regarding fire department inspections is included in Section 3.1.
- The pull stations and alarm horns appear to be in good condition and will require routine maintenance during the assessment period.
