FACILITY CONDITION ASSESSMENT

MBSD MAINTENANCE AND OPERATIONS

1501 Manhattan Beach Boulevard

Date of Report: April 24, 2015

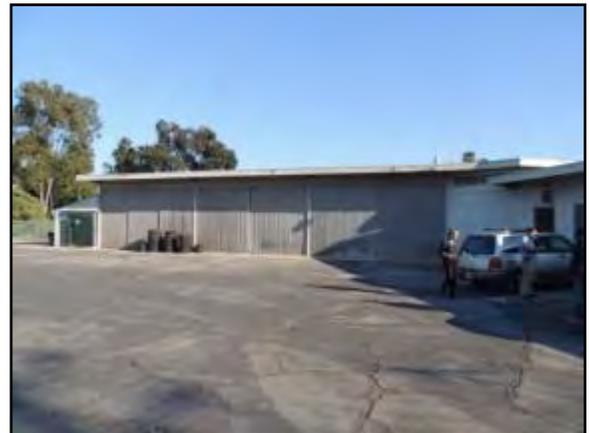
- The property does not have a dedicated paving repair and maintenance contractor. On-site personnel maintain the paving and flatwork or a contractor is retained when required.
- The asphalt pavement is in poor condition. There are significant signs of cracks or surface deterioration. Replacement of the asphalt paving will be required during the assessment period. The cost of this work is included in the Replacement Reserves Report.
- The concrete pavement is in good condition. There are no significant signs of cracks or surface deterioration. Epoxy sealing of minor cracks will be required during the assessment period as part of the property management's routine maintenance program.
- The concrete curbs and sidewalks throughout the property are in good condition. Routine cleaning and maintenance will be required during the assessment period.

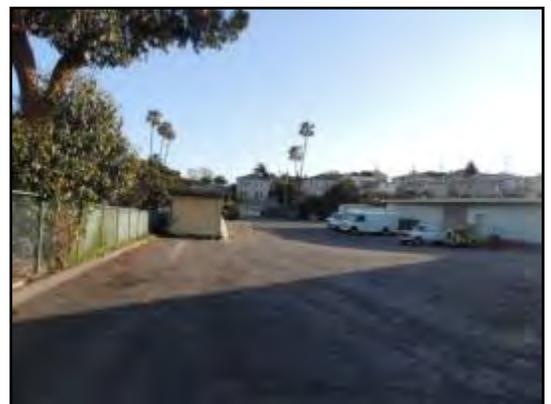
- The exterior site and building light fixtures are in fair condition. Routine maintenance will be required during the assessment period.
- The site fencing is in fair condition and will require routine maintenance during the assessment period.
- The dumpsters are owned and maintained by the refuse contractor.

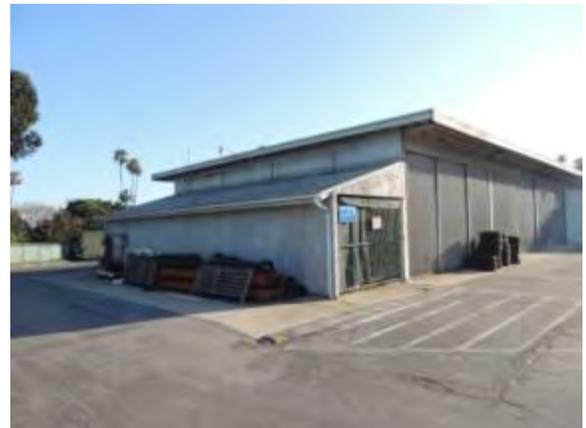
- The property does not have a dedicated roof repair and maintenance contractor. On-site personnel maintain the roofs or a contractor is retained when required.

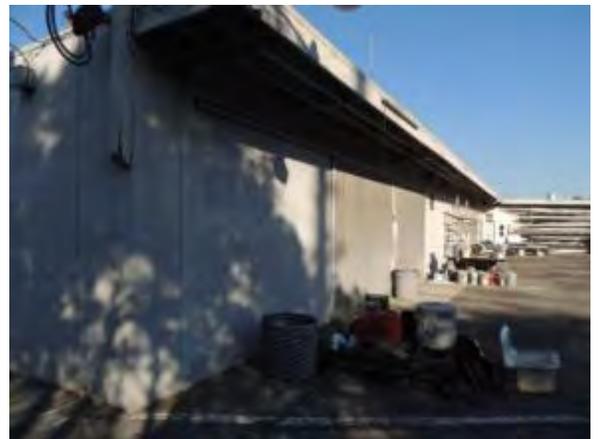
- The exterior finishes are in fair condition. Painting and patching will be required during the assessment period. The cost of this work is included in the Replacement Reserves Report.
- The sealant is flexible, smooth, and in good condition and will require routine maintenance during the assessment period.

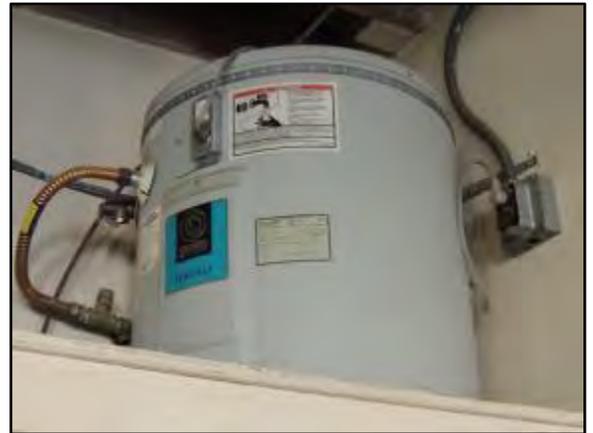
- The water and sewage piping is in poor condition; per facilities personnel, there are constant water clogs and leaks due to deteriorating water and sewage pipes. The water and sewage pipes will need to be replaced. The cost for this work is included in the Short Term Cost Report.
- The water pressure appears to be adequate.
- There is no evidence that the property uses polybutylene piping for the domestic water distribution system.
- The accessories and fixtures in the restrooms are in fair condition. Based on their estimated Remaining Useful Life (RUL), replacement is recommended during the reserve term. The estimated cost for this work is included in the Replacement Reserves Report.

7.2	329062	Replace water distribution piping	500	LF	\$28.90	\$14,450		\$14,450
7.2	329063	Replace sanitary sewer collection piping, 6" SDR 35	500	LF	\$31.60	\$15,800		\$15,800

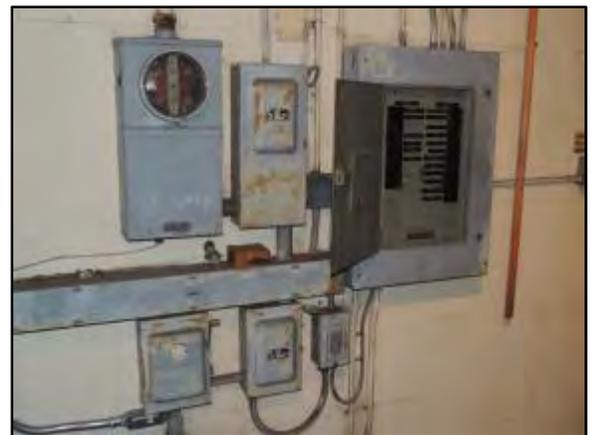
- The on-site electrical systems up to the meters are owned and maintained by the respective utility company.
- The electrical service and capacity appear to be adequate for the property's demands.

- The switchgear, circuit breaker panels, and electrical meters appear to be in fair to poor condition and will require replacement during the assessment period. The cost for this work is included in the Replacement Reserves Report.

7.4	329068	Replace Main Distribution Panel/Switchgear	1	EA	\$4,610.00	\$4,610		\$4,610
Immediate Repairs Total								\$44,016

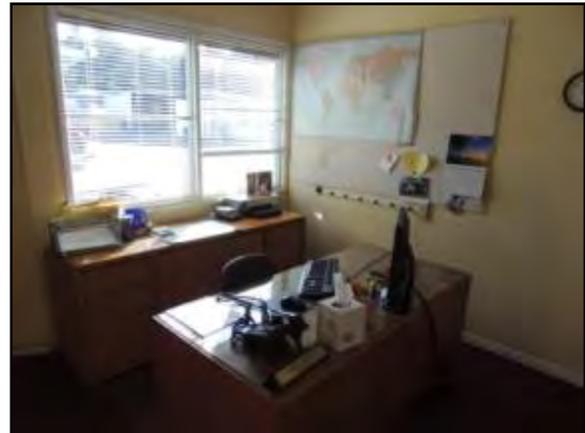
- The interior finishes are in fair condition. Repair, replacement, maintenance, or upgrading of the interior finishes in each tenant space is the responsibility of school district. The costs to replace the floor finishes and to repaint during the assessment period are included in the Replacement Reserves Report.
- The interior doors and door hardware are in good condition and will require routine maintenance during the assessment period.

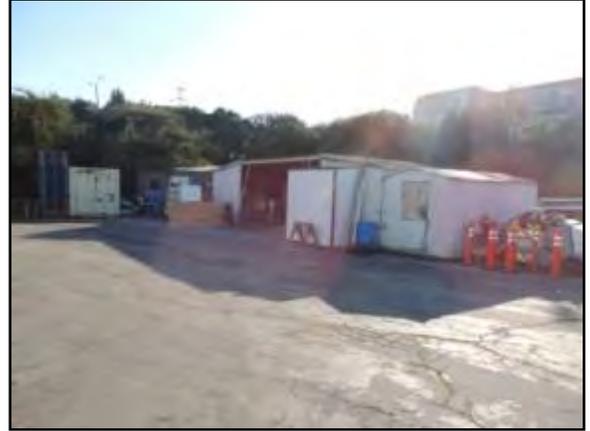
- The storage building and storage containers are in fair condition and will require routine maintenance during the assessment period.

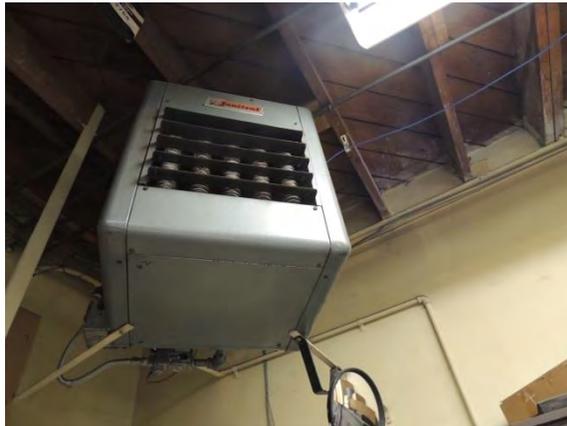
Photo #15: Typical ceiling gas unit heater

3.2	329409	ADA, paint van-accessible space with signage	1	EA	\$420.00	\$420		\$420
6.3	328024	Roof leaks, minor repairs	5	EA	\$500.00	\$2,500		\$2,500
7.1	329057	Warehouse ceiling heater gas-fired 130 MBH	2	EA	\$1,893.00	\$3,786		\$3,786

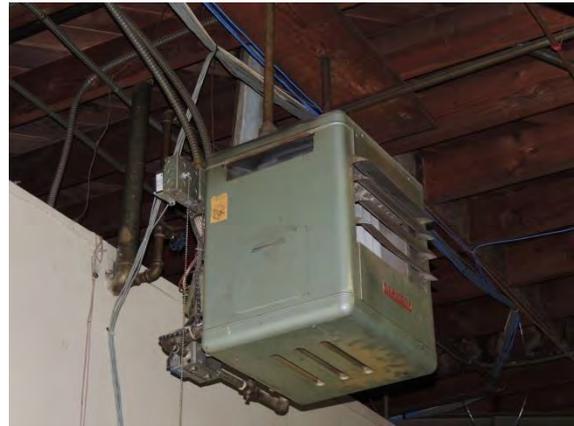
Photo #16: Typical ceiling gas unit heater

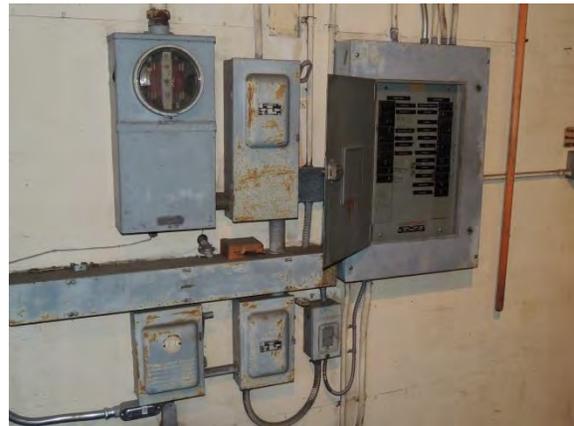
Photo #18: Electrical panels
