FACILITY CONDITION ASSESSMENT

MBSD DISTRICT ADMINISTRATION

EMG Project #: 112851.15R-010.017

Date of Report: April 21, 2015

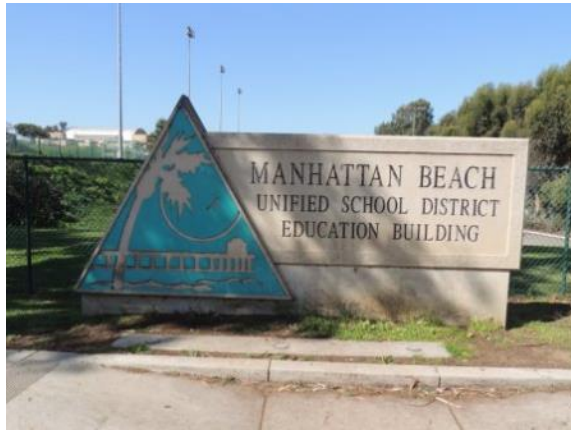
Photo #1:	Property signage
-----------	------------------

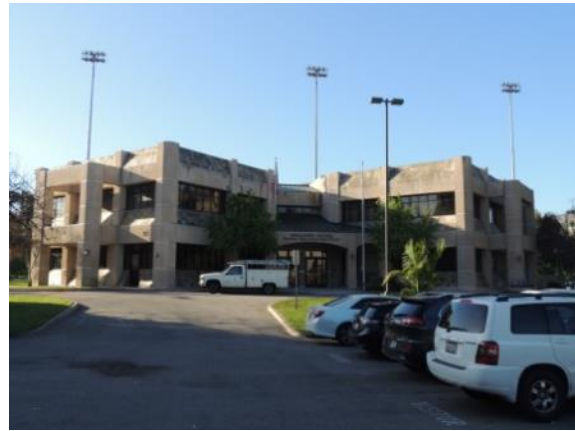
Photo #2:	Administration building
-----------	-------------------------

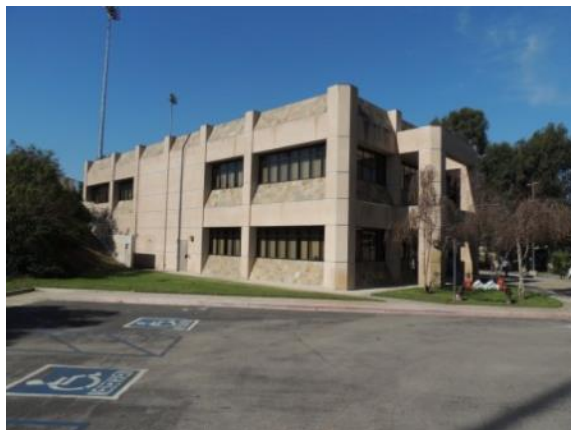
Photo #3:	Administration building
-----------	-------------------------

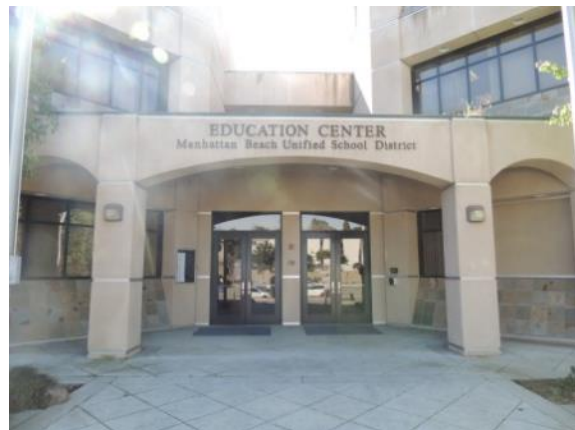
Photo #4:	Main entrance
-----------	---------------

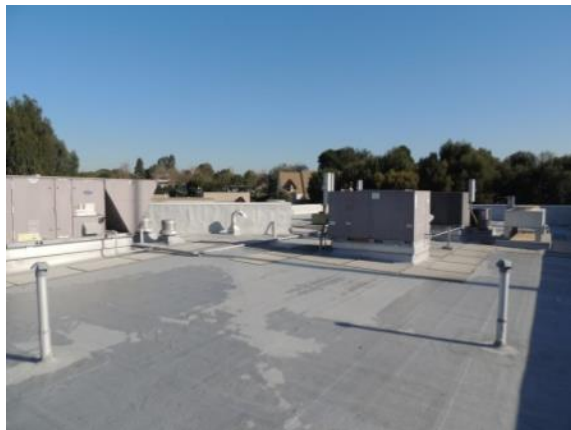
Photo #5:	Roofing
-----------	---------

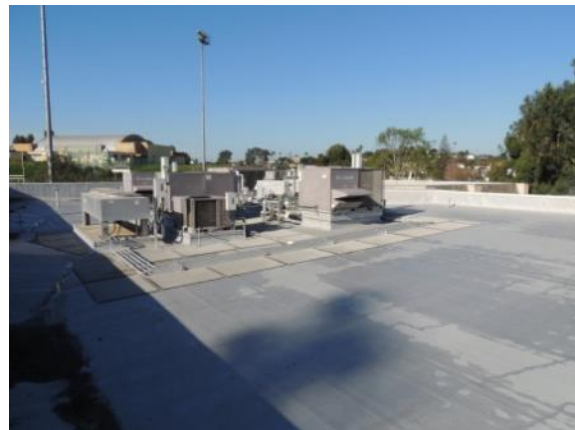
Photo #6:	Roofing
-----------	---------

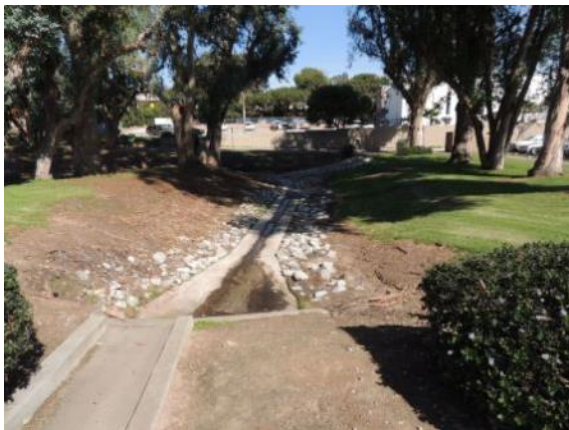
Photo #9:	Detention pond
-----------	----------------

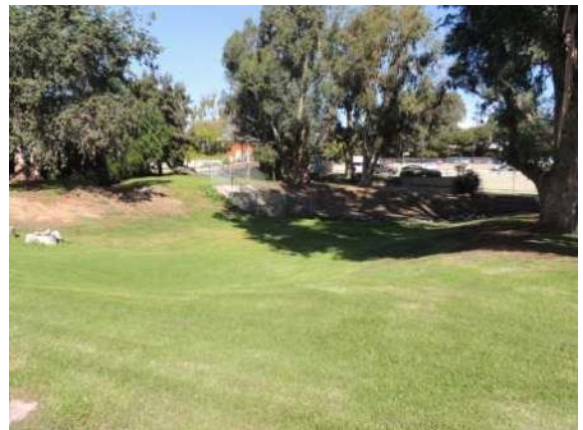
Photo #10:	Detention pond
------------	----------------

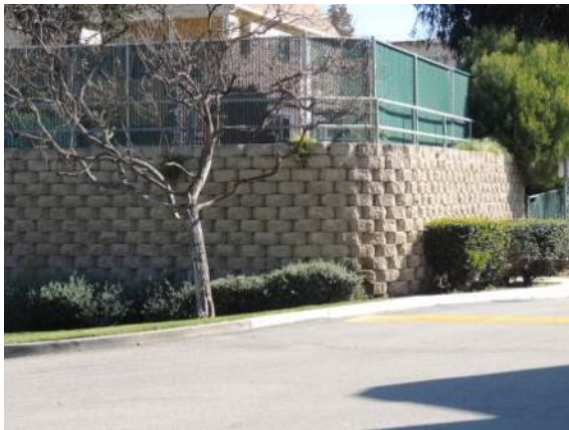
Photo #11:	Retaining wall
------------	----------------

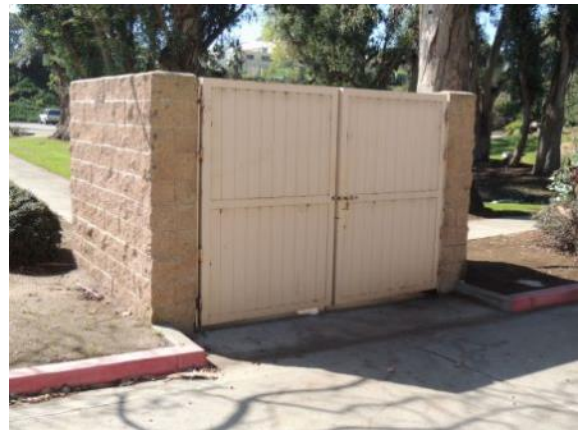
Photo #12:	Dumpster enclosure
------------	--------------------

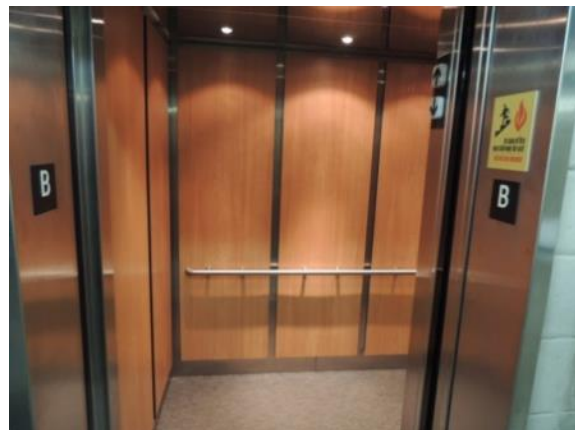
Photo #24:	Elevator
---------------	----------

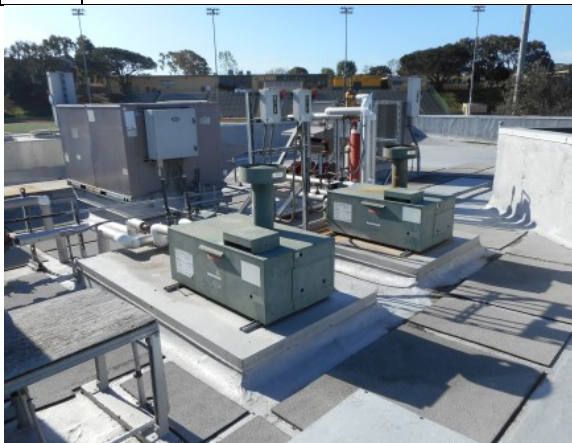
Photo #33:	Water boilers
---------------	---------------

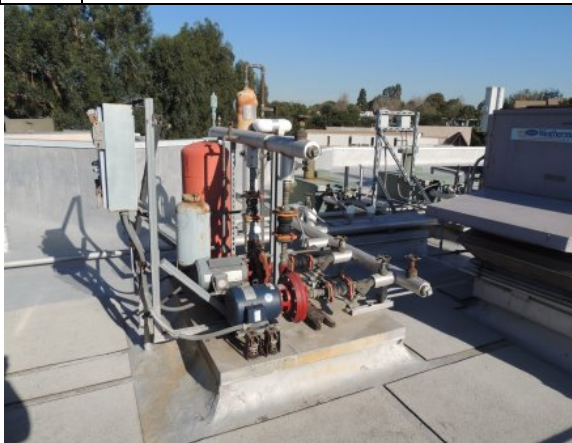
Photo #35:	Heating water pumps
---------------	---------------------

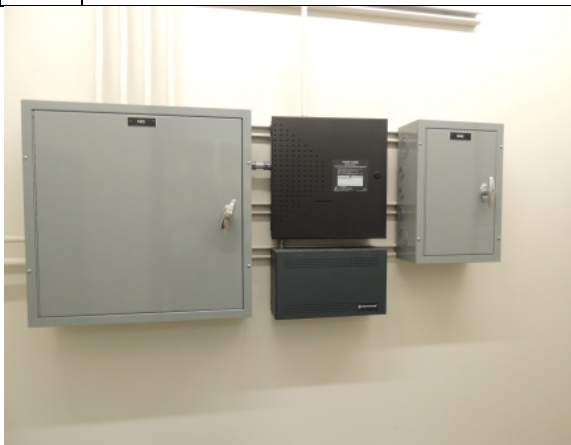
Photo #47:	Fire alarm panels
------------	-------------------
