FACILITY CONDITION ASSESSMENT

FACILITY CONDITION ASSESSMENT OF

MEADOWS ELEMENTARY

1200 North Meadows Avenue
Manhattan Beach, California 90266

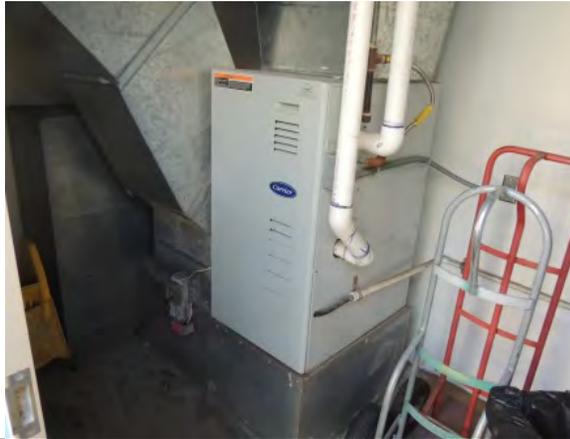
Photo #31: Typical gas furnace in mechanical closet

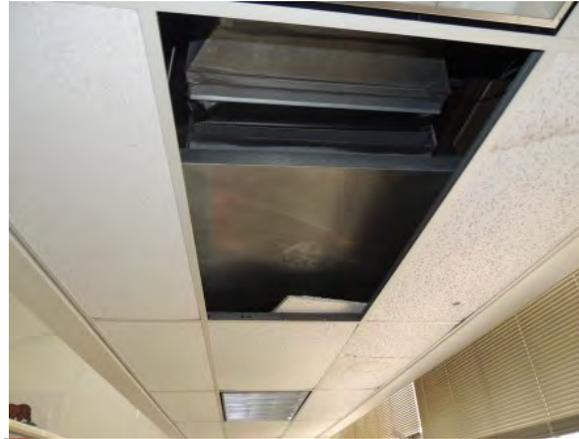
Photo #32: Typical gas furnace in ceiling space

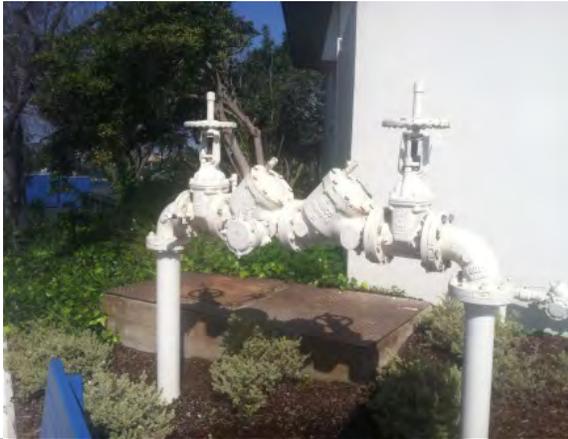
Photo #43: Backflow prevention assembly

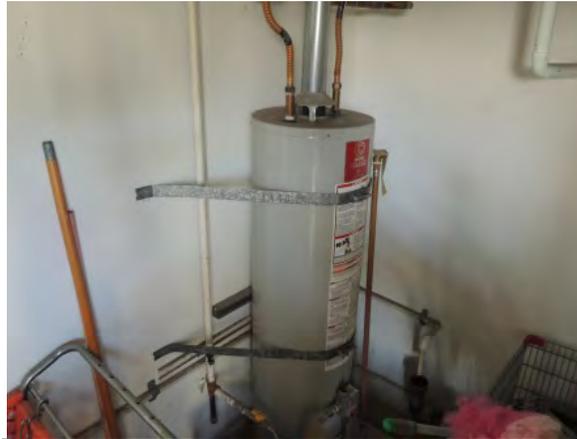
Photo #44: Hot water heater

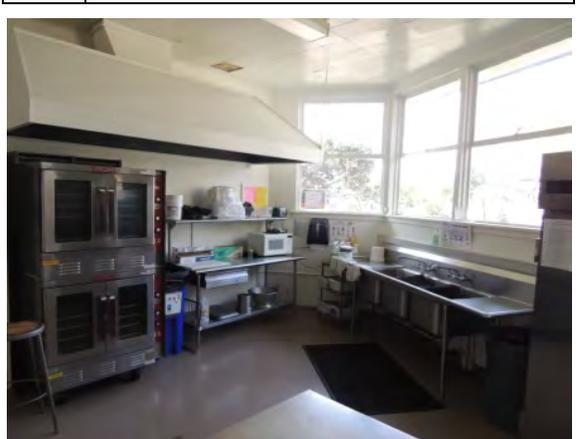
Photo #48: Kitchen hood
