FACILITY CONDITION ASSESSMENT

PACIFIC ELEMENTARY

1200 Pacific Avenue
Manhattan Beach, California 90266

Date of Report: April 8, 2015

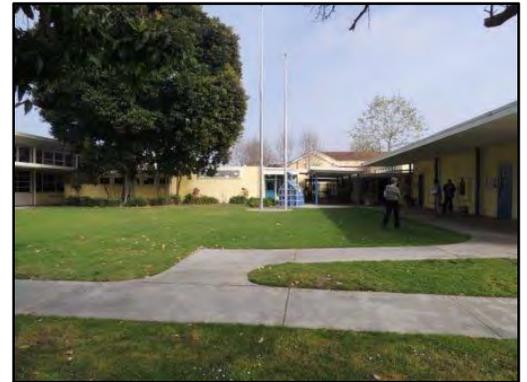
- The property identification signs are in good to fair condition. The main property sign will need replacement during the assessment period. The cost of this work is included in the Replacement Reserves Report.
- The exterior site and building light fixtures are in good condition. Routine maintenance will be required during the assessment period.
- The site fencing is in good to fair condition and will require routine maintenance during the assessment period. Scraping and painting is considered to be routine maintenance.
- The dumpsters are owned and maintained by the refuse contractor.

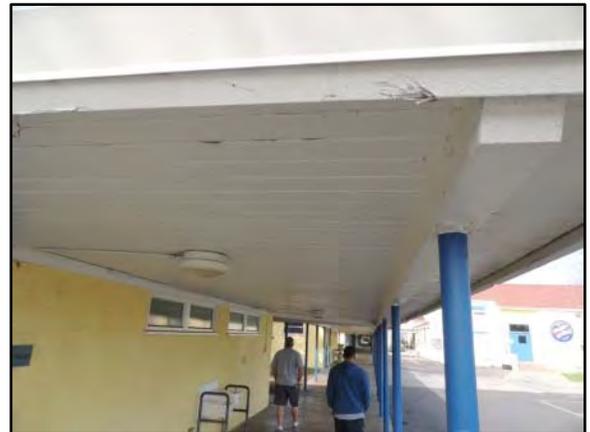
- The superstructure is exposed in some locations, which allows for limited observation. Walls and floors appear to be plumb, level, and stable. There are no significant signs of deflection or movement.
- Per the owner's representative, many buildings have isolated evidence of wood framing deterioration due to insect activity. See Section 1.2.

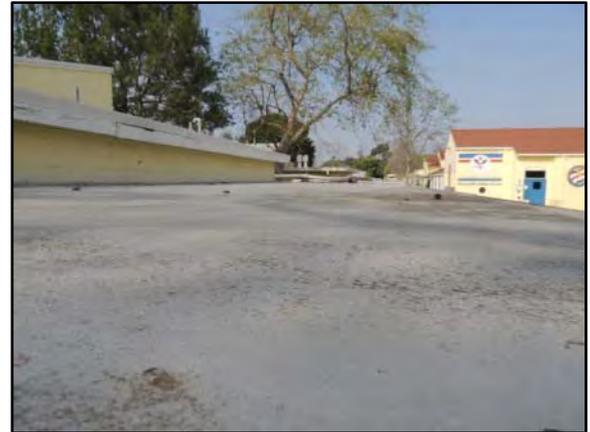
- There is no evidence of fire retardant treated plywood (FRT).
- The roof flashings are in good to fair condition. Some areas of flashings have failed and will require repair. The cost of this work is included in the Immediate Repairs Report.

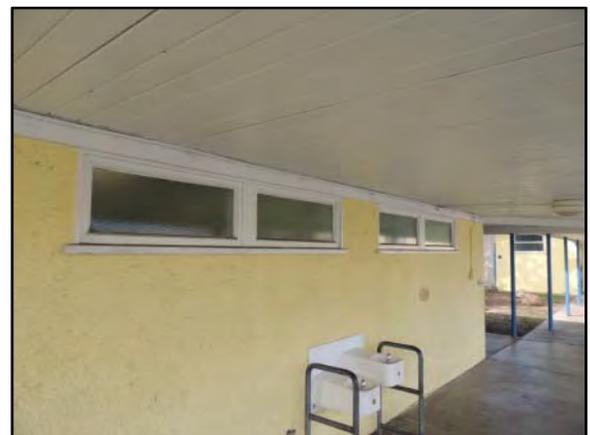
- The exterior finishes are in good to fair condition. Painting and patching will be required during the assessment period. The cost of this work is included in the Replacement Reserves Report.
- The sealant is flexible, smooth, and in good condition and will require routine maintenance during the assessment period.
