## FACILITY CONDITION ASSESSMENT

## ROBINSON ELEMENTARY

EMG Project #: 112851.15R-006.017

On-Site Date: February 17, 2015

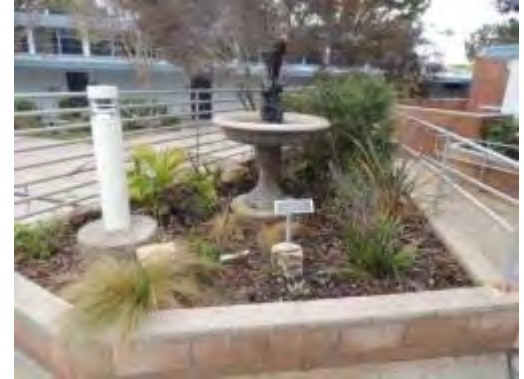
- The topography and adjacent uses do not appear to present conditions detrimental to the property.
- The landscape materials are in good to fair condition and will require routine maintenance during the assessment period.
- The underground irrigation system appears to be in good working order. Replacement of sprinkler heads and minor repairs will be required during the assessment period. This work is considered to be routine maintenance.
- The retaining walls are in good to fair condition. The retaining walls will require repointing during the assessment period. The cost of this work is included in the Replacement Reserves Report.

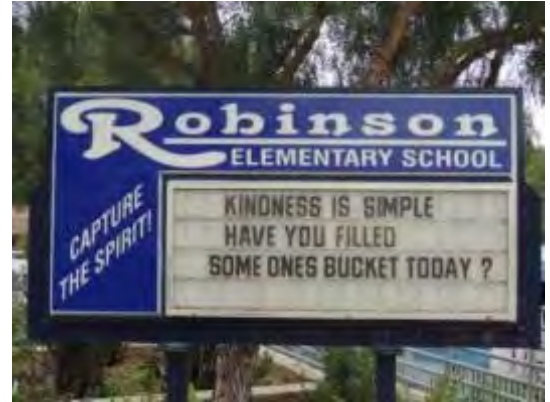
- The property and tenant identification signs are in good condition. Routine maintenance will be required during the assessment period.
- The exterior site and building light fixtures are in good condition. Routine maintenance will be required during the assessment period.
- The site fencing is in good condition and will require routine maintenance during the assessment period. Painting is considered to be routine maintenance.

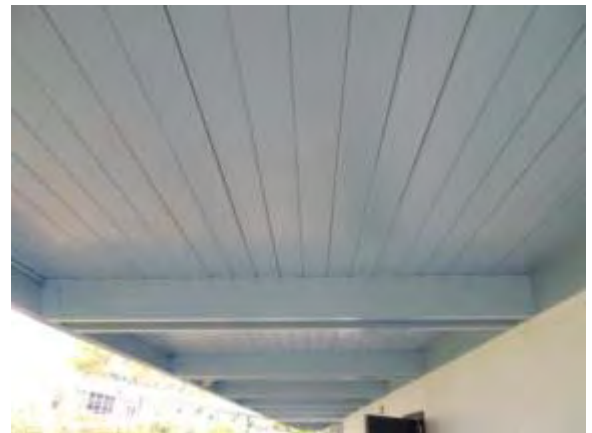
- The superstructure is exposed in some locations, which allows for limited observation. Walls and floors appear to be plumb, level, and stable. There are no significant signs of deflection or movement.
- Per the owner's representative, all buildings have isolated evidence of wood framing deterioration due to insect and several have been serviced. A local, licensed exterminator must be retained to treat the property as required to eliminate the pests and associated threat. See Section 1.2.

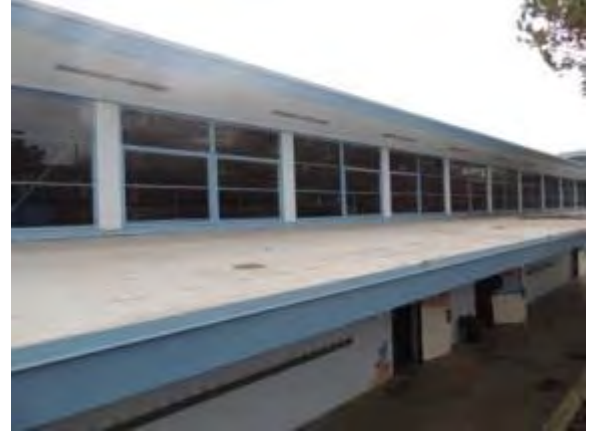
- The property does not have a dedicated roof repair and maintenance contractor. On-site personnel maintain the roofs or a contractor is retained when required. or

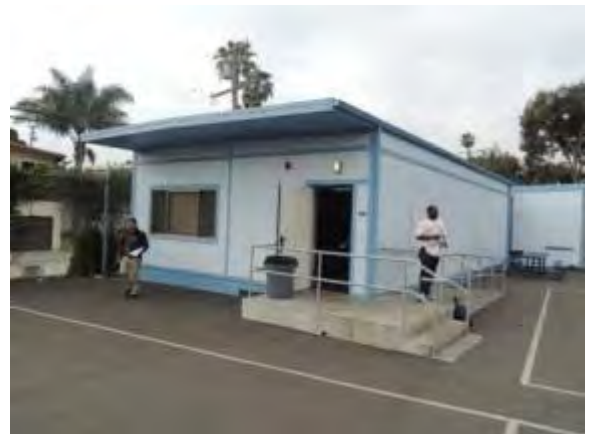
- The exterior stairs and ramps are in good condition and will require routine maintenance during the assessment period.
- The exterior balusters and handrails are in fair to poor condition. Sections are rusted and will need to be repaired or replaced. The cost of this work is included in the Replacement Reserves Report.

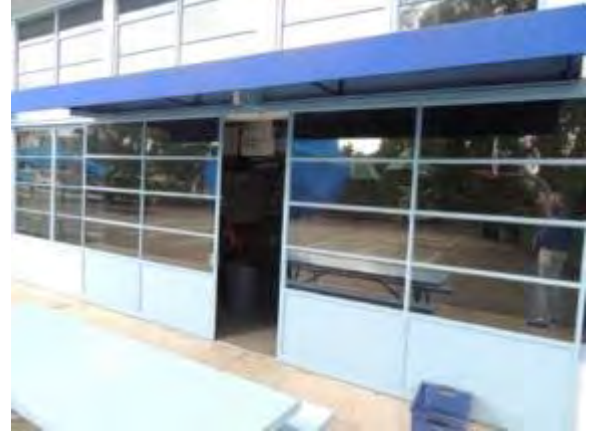
- There is no evidence of window leaks or window condensation. The windows are in good condition and will require routine maintenance during the assessment period.
- The exterior doors and door hardware are in good condition and will require routine maintenance during the assessment period.
- The exterior sliding doors and hardware are in fair condition being that they are generally difficult to open. The sliding doors will require routine maintenance during the assessment period.

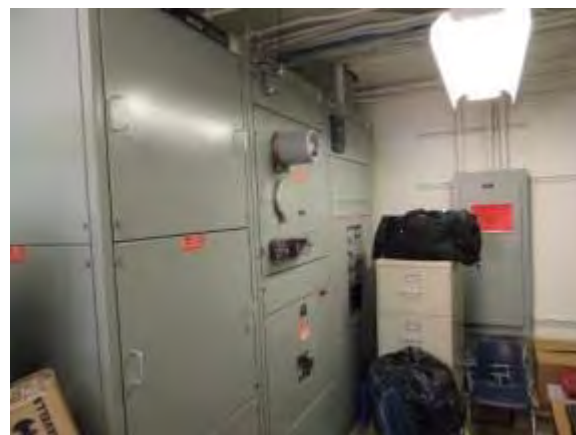
- The on-site electrical systems up to the meter are owned and maintained by the respective utility company.
- The electrical service and capacity appear to be adequate for the property's demands.
- The switchgear, circuit breaker panels, and electrical meters appear to be in good condition and will require routine maintenance during the assessment period.

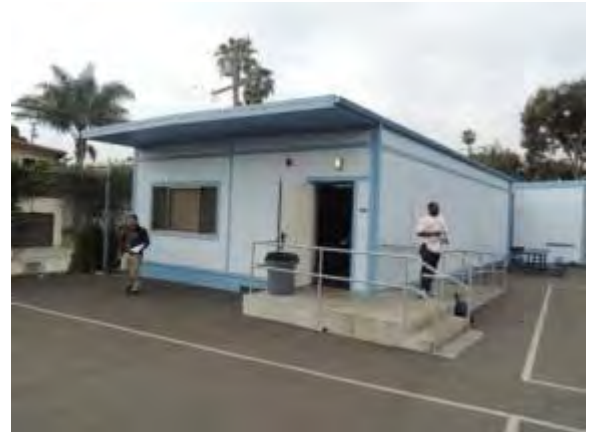
- The modular classrooms are in good to fair condition and will require routine maintenance during the assessment period.
- The maintenance and storage sheds are in fair to poor condition, the roofing and siding are exhibiting signs of deterioration. The cost of this work is included in the Immediate Reserves Report.

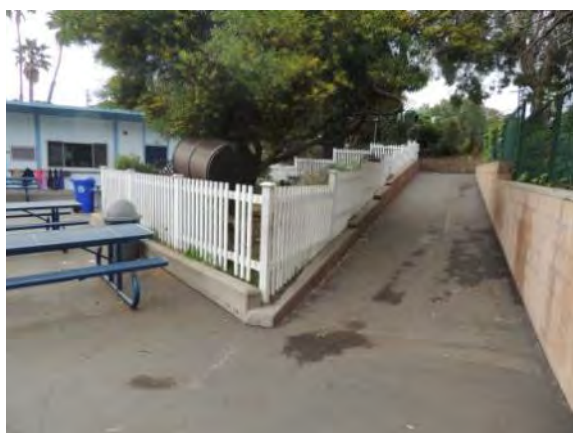
Photo #23:	Retaining walls
---------------	-----------------

5.4	<a href="#">323967</a>	G2042 Point brick retaining wall	20	20	0	2	CSF	\$948.00	\$1,896	\$1,896																				\$1,896		
6.3	<a href="#">323954</a>	B3011 Replace Existing EPDM Roof with PVC Membrane Roofing	20	19	1	2860	SQ	\$1,135.17	\$3,246,586		\$3,246,586																			\$3,246,586

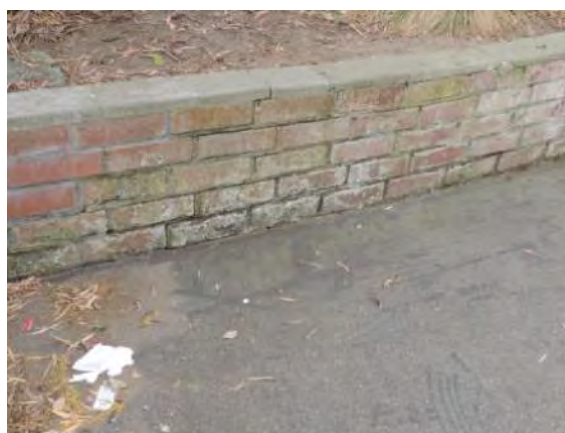
Photo #24:	Retaining wall
---------------	----------------

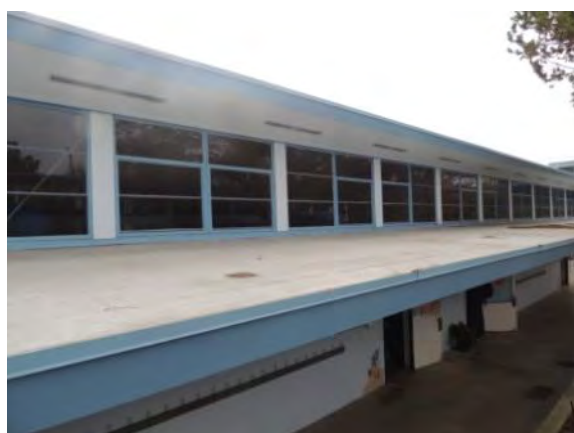
Photo #27:	Roofing
---------------	---------

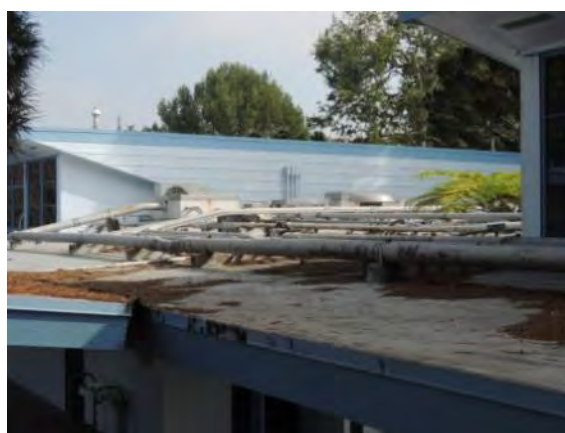
Photo #28:	Roofing
---------------	---------

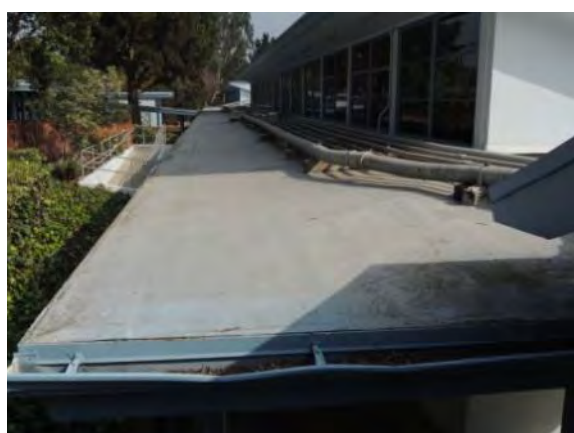
Photo #29:	Roofing
---------------	---------

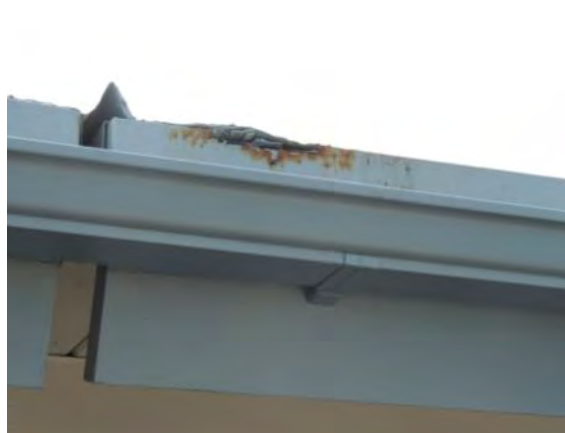
Photo #30:	Flashing and gutters
---------------	----------------------

6.3	<a href="#">326801</a>	B3011 Misc. roof gutter repairs	0	0	0	6	Patch	\$375.00	\$2,250	\$2,250																				\$2,250		
6.3	<a href="#">326800</a>	B3011A Built-up roofing minor membrane repairs - (2% of roof area)	0	0	0	10	SQ	\$453.35	\$4,534	\$4,534																				\$4,534
