FACILITY CONDITION ASSESSMENT

MANHATTAN BEACH MIDDLE SCHOOL

1501 North Redondo Avenue

Date of Report: April 20, 2015

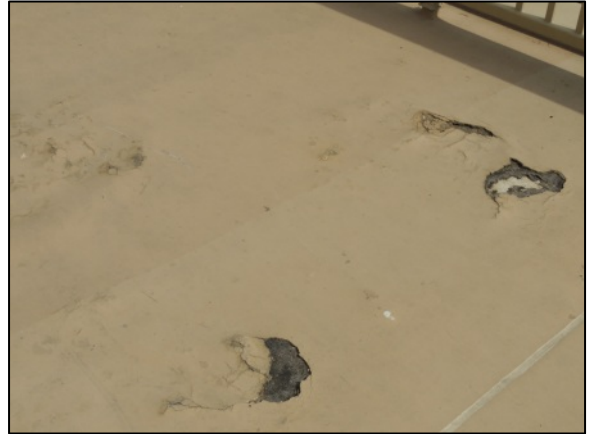
- The patio slabs are in good condition. There are no significant signs of movement, settlement, or cracking.
- The balcony decks are in fair to poor condition. Severe deterioration was observed on the second floor courtyard and walkways in the location above the main office. See Section 1.2.
- The balcony guardrails are in good condition and will require routine maintenance during the assessment period.

- The balconies show signs of deterioration. An in-depth balcony study is recommended to determine the exact cause of the failure. A professional engineer must be retained to analyze the existing condition, provide recommendations and, if necessary, estimate the scope and cost of any required repairs. The cost to retain an engineer is included in the Replacement Reserves Report. The cost for any possible subsequent repairs is not included in the cost tables.

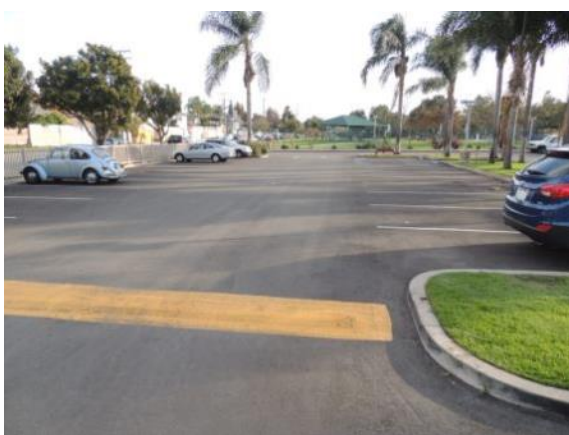
Photo #17:	Parking lot
---------------	-------------

5.2	Parking areas and driveways		327985	G2022 Patch, Repair and Seal Coat asphalt driveway	15	5	10	46700	SF		\$0.50	\$23,350											\$23,350										\$23,350

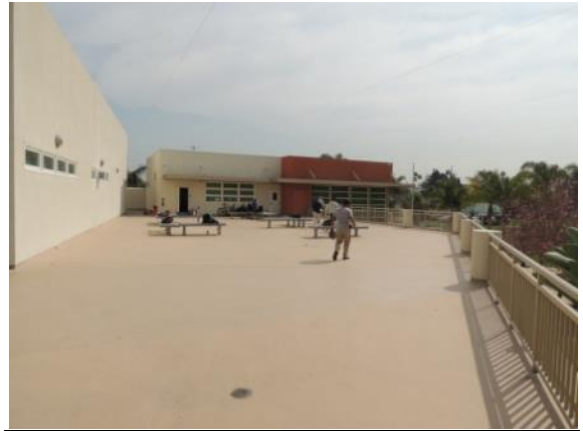
Photo #20:	Second floor balcony
------------	----------------------

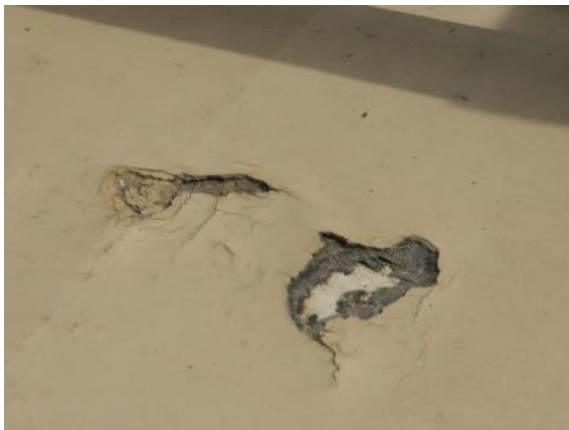
Photo #21:	Second floor balcony floor issues
------------	-----------------------------------

1.2	Upper level balconies		327998	_0001 Balcony study to determine slope of balconies and proper drainage	0	0	0	0	1	EA	\$4,500.00	\$4,500	\$4,500																				\$4,500

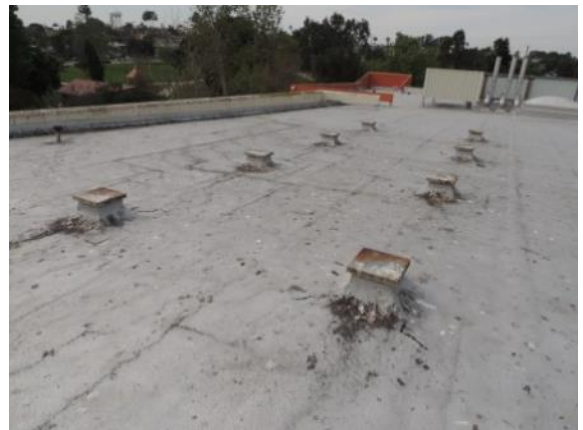
Photo #22:	Roofing
------------	---------

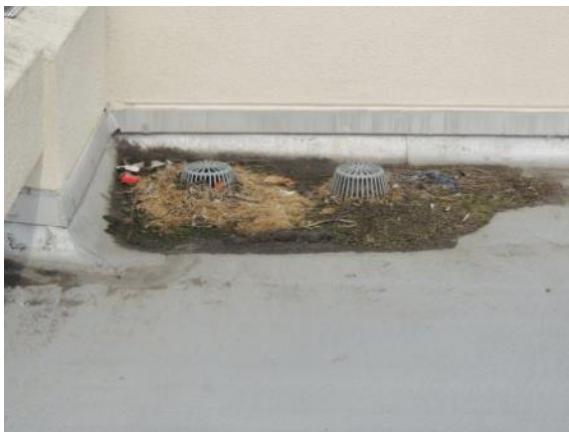
Photo #23:	Roof drains
------------	-------------

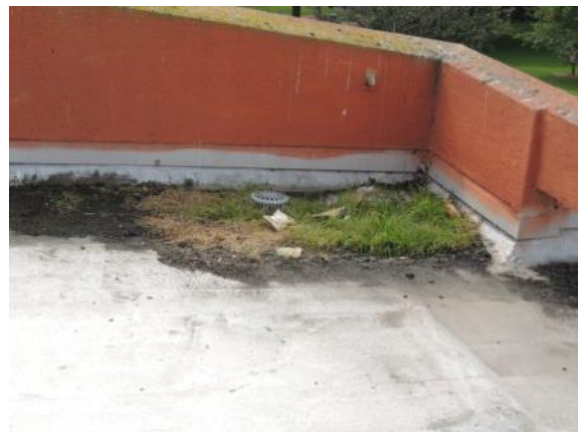
Photo #24:	Roof drains
------------	-------------

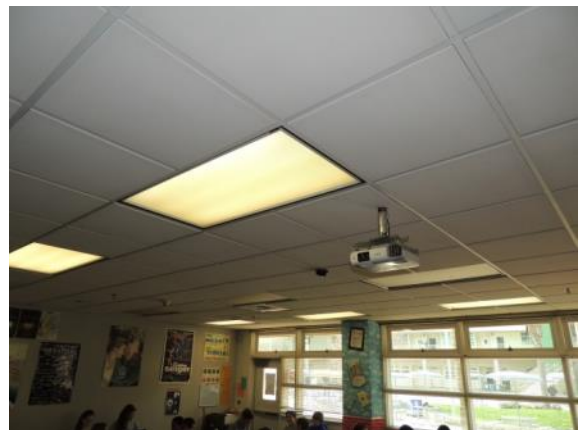
Photo #48:	Typical classroom lighting
------------	----------------------------

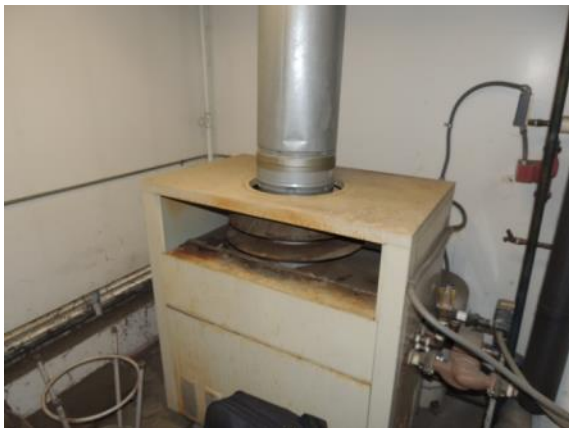
Photo #51:	Hot water boiler for locker room showers
------------	--

8.4	Locker Room Showers		328685	D3021 Replace water boiler, gas 550 to 765 MBH	30	17	13	1	EA		\$17,800.00	\$17,800														\$17,800								\$17,800
