FACILITY CONDITION ASSESSMENT

PENNEKAMP ELEMENTARY

EMG Project #: 112851.15R-005.017

Date of Report: April 7, 2015

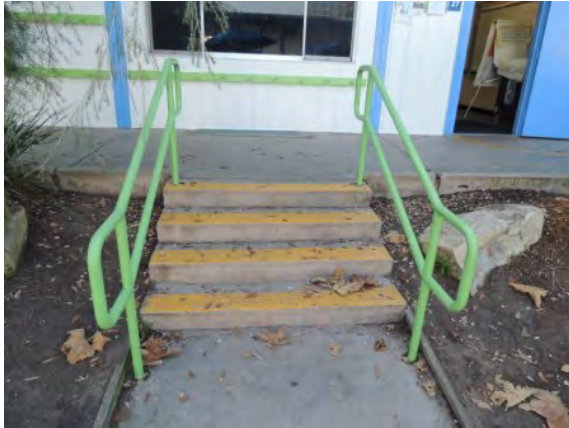
Photo #19:	Exterior stairs
------------	-----------------

- The exterior stairs, balusters, and handrails are in good condition and will require routine maintenance during the assessment period.

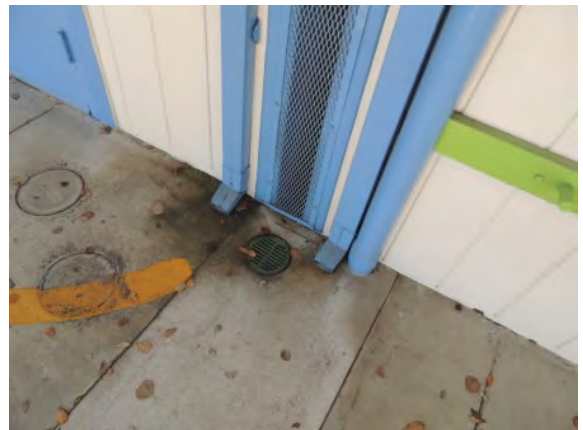
Photo #28:	Downspout
------------	-----------

According to property management personnel, major capital expenditures planned for next year includes replacement of gutters.

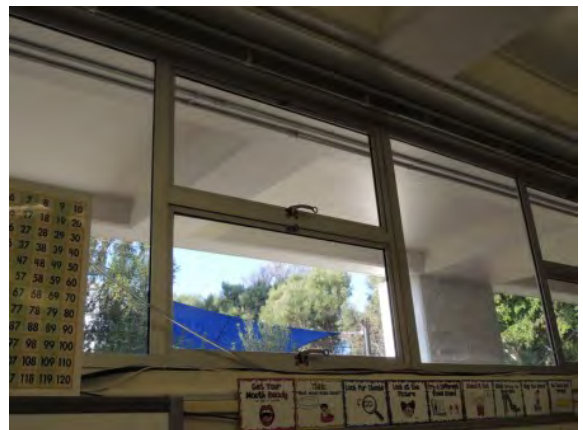
Photo #30:	Classroom windows
------------	-------------------

- There is no evidence of window leaks or window condensation. The windows are in good condition and will require routine maintenance during the assessment period.
- The exterior doors and door hardware are in good condition and will require routine maintenance during the assessment period.
- The exterior sliding doors and hardware are in fair condition being that they are generally difficult to open. The sliding doors will require routine maintenance during the assessment period.

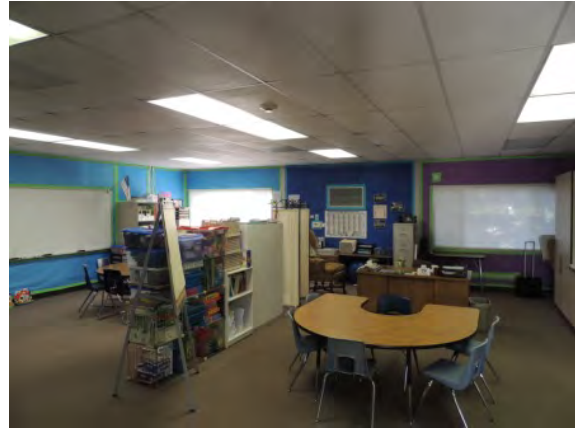
- The modular classrooms are in fair to poor condition, the roofing and siding are exhibiting signs of deterioration. The cost of this work is included in the Immediate Reserves Report.
- The maintenance and storage sheds are in good to fair condition and will require routine maintenance during the assessment period.

Photo #44:	Portable classroom
------------	--------------------

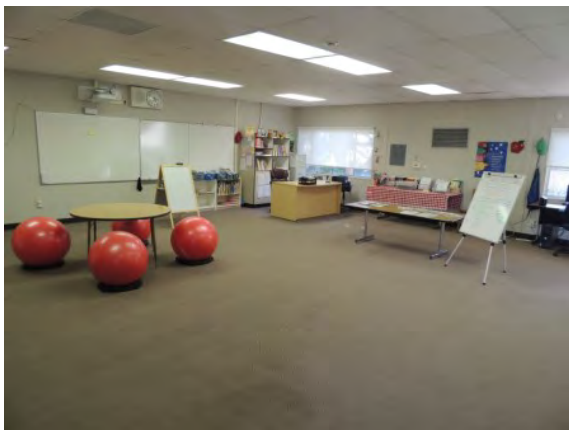
Photo #45:	Portable classroom
------------	--------------------

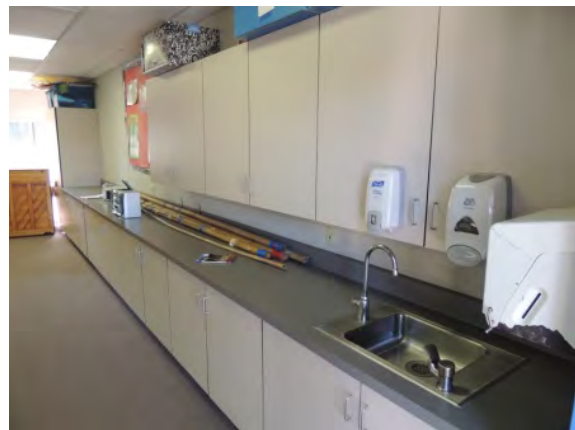
Photo #46:	Portable classroom
------------	--------------------
