FACILITY CONDITION ASSESSMENT

MIRA COSTA HIGH SCHOOL

1401 Artesia Boulevard

EMG Project #: 112851.15R-008.017

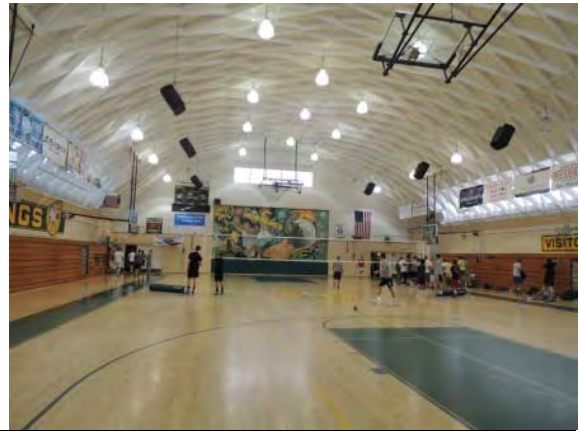
Photo #26: Gymnasium

- The interior finishes are in good condition. Repair, replacement, maintenance, or upgrading of the interior finishes is the responsibility of the school district. The wood floor in the Gymnasium will need to be sanded during the assessment period. The replacement of floor finishes and repainting will be required during the assessment period. Those costs are included in the Replacement Reserves Report.
- The interior doors and door hardware are in good condition and will require routine maintenance during the assessment period.

8.1	Offices, classrooms	329292	C3024 Replace Vinyl tile	18	6	12	5000	SY	\$67.75	\$338,750														\$338,750								\$338,750							
8.1	Gymnasiums	329289	C3024 Sand and refinish hardwood floor	10	5	5	25000	SF	\$5.50	\$137,500							\$137,500										\$137,500					\$275,000
