FACILITY CONDITION ASSESSMENT

MBSD MAINTENANCE AND OPERATIONS

1501 Manhattan Beach Boulevard

Date of Report: April 24, 2015

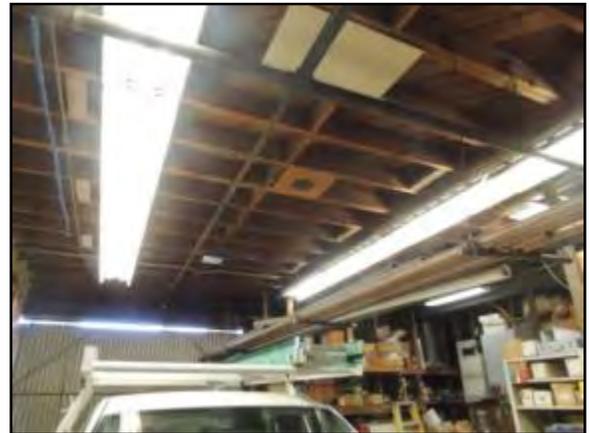
- The superstructure is exposed in some locations, which allows for limited observation. Walls and floors appear to be plumb, level, and stable. There are no significant signs of deflection or movement.

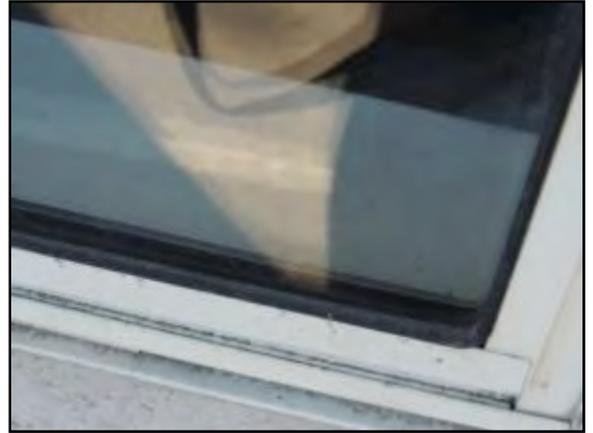
- There is no evidence of window leaks or window condensation. The windows are in good condition and will require routine maintenance during the assessment period.
- The exterior doors and door hardware are in fair condition and will require routine maintenance during the assessment period.
