FACILITY CONDITION ASSESSMENT

FACILITY CONDITION ASSESSMENT OF

MEADOWS ELEMENTARY

1200 North Meadows Avenue
Manhattan Beach, California 90266

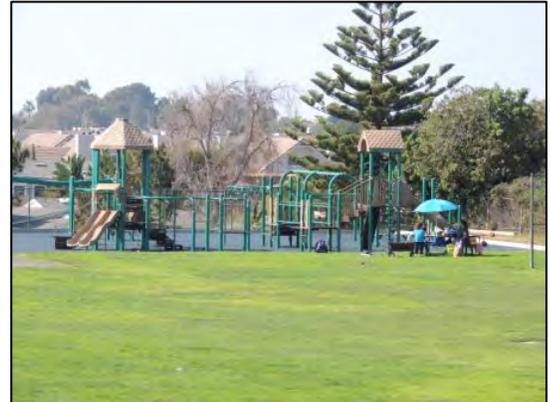
- The topography and adjacent uses do not appear to present conditions detrimental to the property.
- The landscape materials are in good condition and will require routine maintenance during the assessment period.
- The underground irrigation system appears to be in good working order. Replacement of sprinkler heads and minor repairs will be required during the assessment period. This work is considered to be routine maintenance.

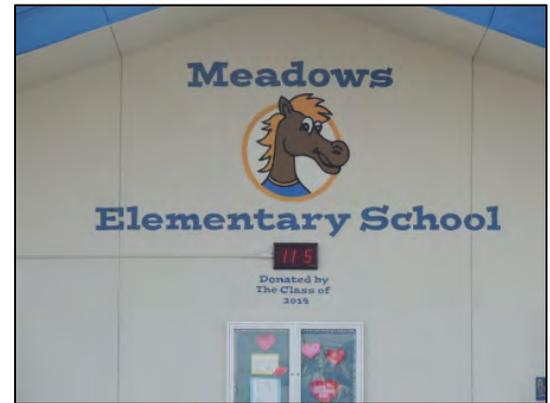
- The property and tenant identification signs are in good condition. Routine maintenance will be required during the assessment period.
- The exterior site and building light fixtures are in good condition. Routine maintenance will be required during the assessment period.
- The site fencing is in good condition and will require routine maintenance during the assessment period.
- The dumpsters are owned and maintained by the refuse contractor. The dumpster enclosures, slabs, and gates are in good condition and will require routine maintenance during the assessment period.

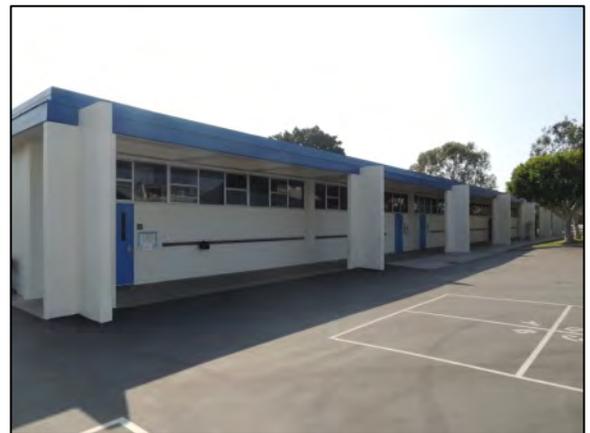
- The exterior finishes are in good condition. Painting and patching will be required during the assessment period. The cost of this work is included in the Replacement Reserves Report.
- The sealant is flexible, smooth, and in good condition and will require routine maintenance during the assessment period.

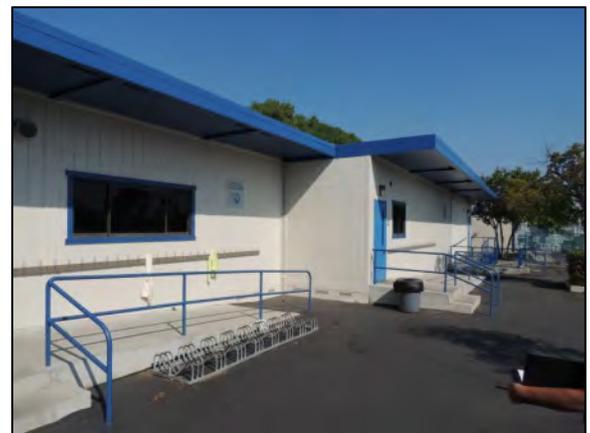
- The exterior stairs, balusters, and handrails are in good condition and will require routine maintenance during the assessment period.

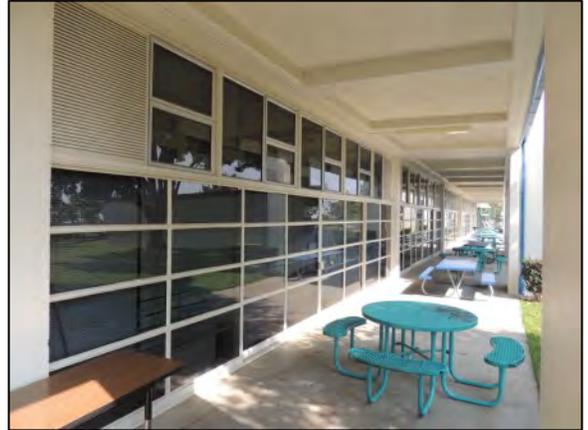
- There is no evidence of window leaks or window condensation. The windows are in good condition and will require routine maintenance during the assessment period.
- The exterior doors and door hardware are in good condition and will require routine maintenance during the assessment period.

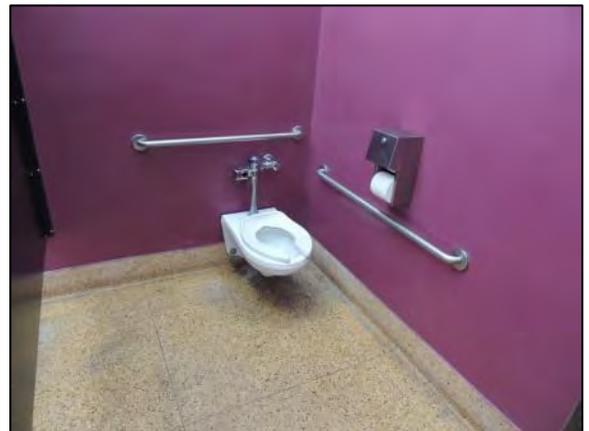
- The plumbing systems appear to be well maintained and in fair condition.
- Facilities personnel informed us that the water pressure appears to be inadequate. A follow up study by a specialized consultant should be conducted. See Section 1.2.
- There is no evidence that the property uses polybutylene piping for the domestic water distribution system.
- The accessories and fixtures in the restrooms are in fair condition and will require routine maintenance during the assessment period. Facilities personnel informed us that there are some leaks that will require repairs. The cost to repair water leaks is relatively insignificant, and the work can be performed as part of the property management's routine maintenance program.

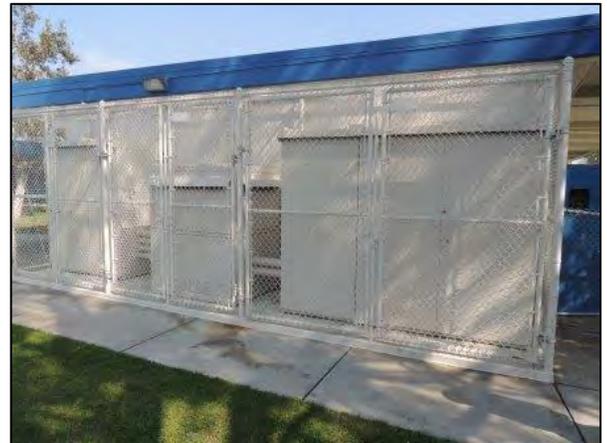
- The on site electrical systems up to the meters are owned and maintained by the respective utility company.
- The electrical service and capacity appear to be adequate for the property's demands.
- The switchgear, circuit breaker panels, and electrical meters appear to be in fair condition and will require routine maintenance during the assessment period.

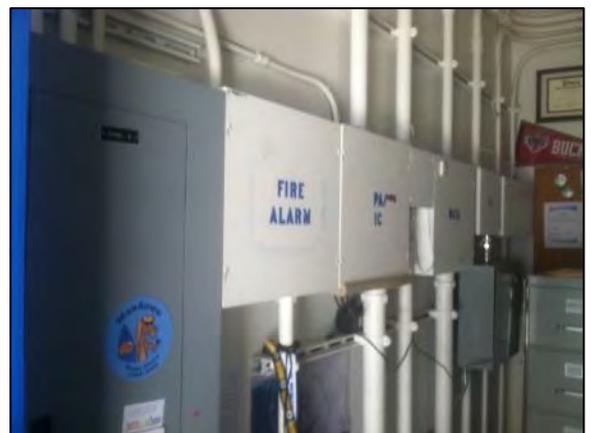
- Information regarding fire department inspections is included in Section 3.1.
- The pull stations and alarm horns appear to be in good condition and will require routine maintenance during the assessment period.

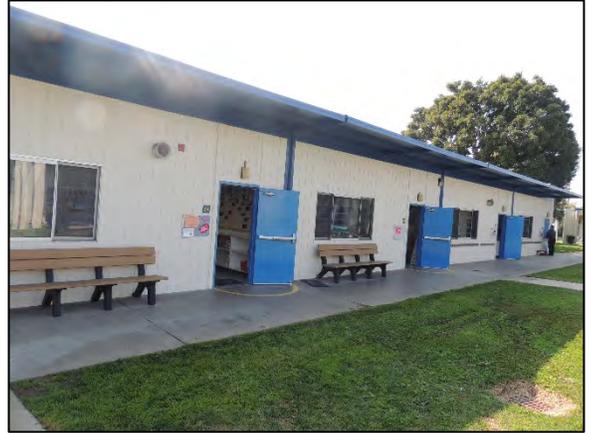
- The modular classrooms are in good to fair condition and will require routine maintenance during the assessment period.
- The maintenance and storage sheds are in fair to poor condition, the roofing and siding are exhibiting signs of deterioration. The cost of this work is included in the Immediate Reserves Report.

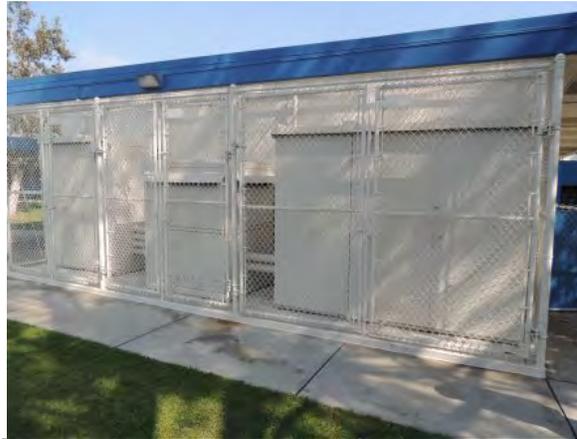
Photo #38:	Electrical equipment
------------	----------------------

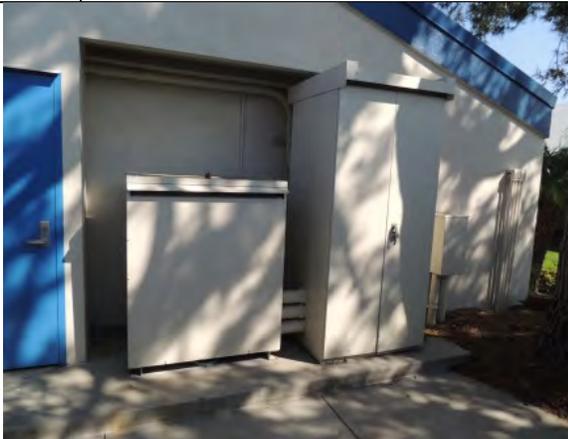
Photo #39:	Electrical equipment
------------	----------------------

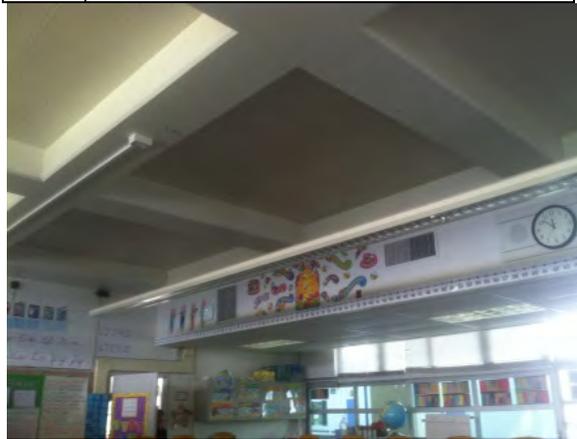
Photo #40:	Classroom lighting
------------	--------------------

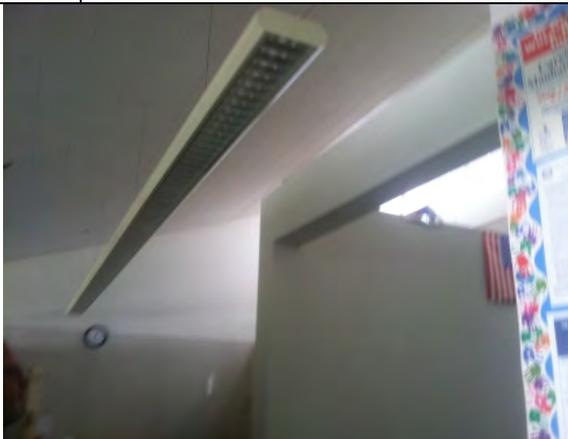
Photo #41:	Typical classroom light fixture
------------	---------------------------------

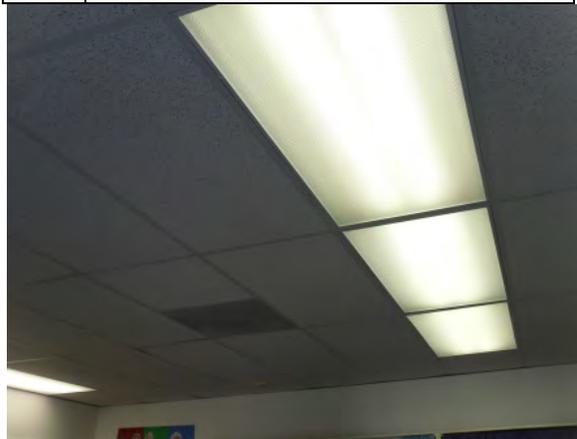
Photo #42:	Typical portable classroom light fixture
------------	--

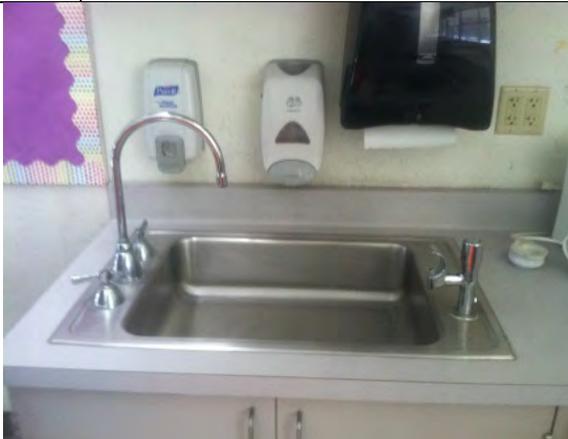
Photo #45: Typical classroom sink

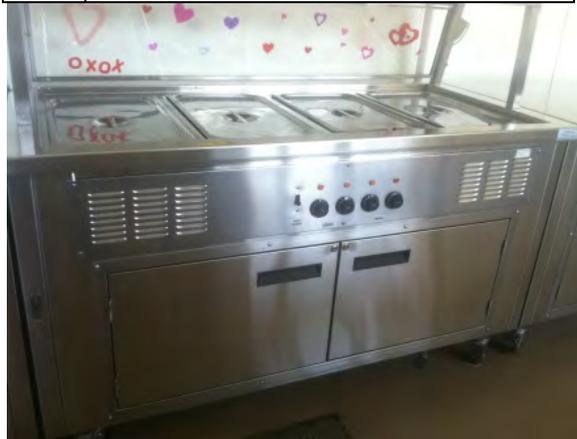
Photo #46: Cafeteria appliances

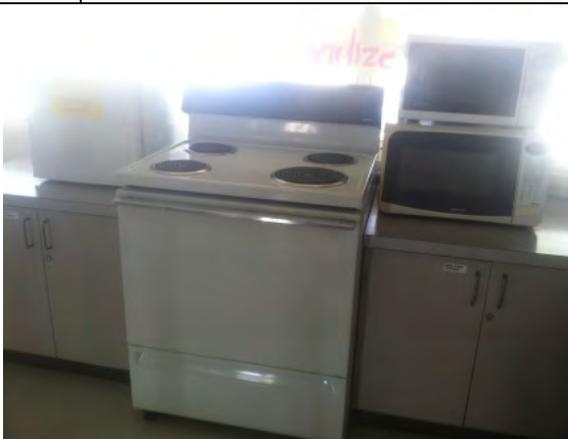
Photo #47: Kitchen appliances
