## FACILITY CONDITION ASSESSMENT

## ROBINSON ELEMENTARY

EMG Project #: 112851.15R-006.017

On-Site Date: February 17, 2015

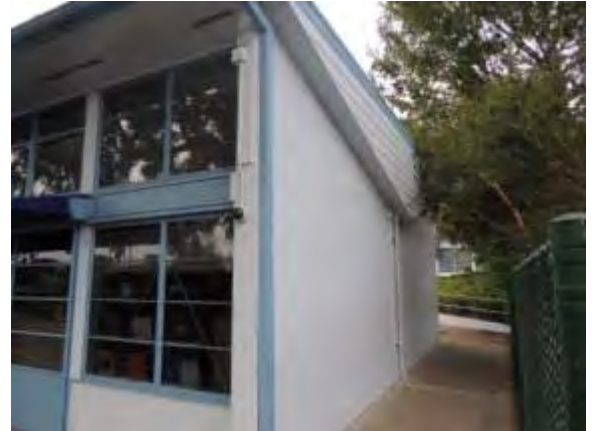
- The exterior finishes are in good condition. Painting and patching will be required during the assessment period. The cost of this work is included in the Replacement Reserves Report.
- The sealant is flexible, smooth, and in good condition and will require routine maintenance during the assessment period.

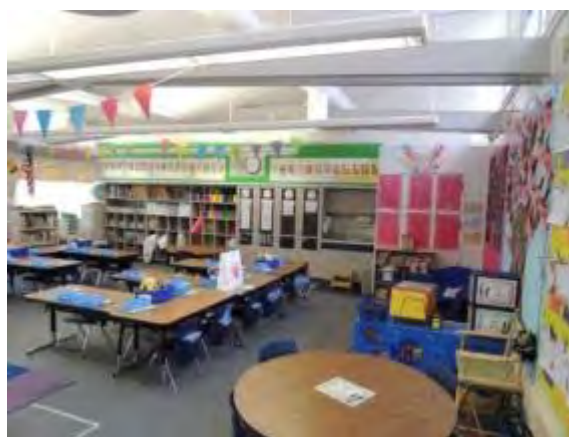
- The interior finishes are in good to fair condition. The cost of this work is included in the Replacement Reserves Report.
- The interior doors and door hardware are in good condition and will require routine maintenance during the assessment period.
