FACILITY CONDITION ASSESSMENT

MANHATTAN BEACH MIDDLE SCHOOL

1501 North Redondo Avenue

Date of Report: April 20, 2015

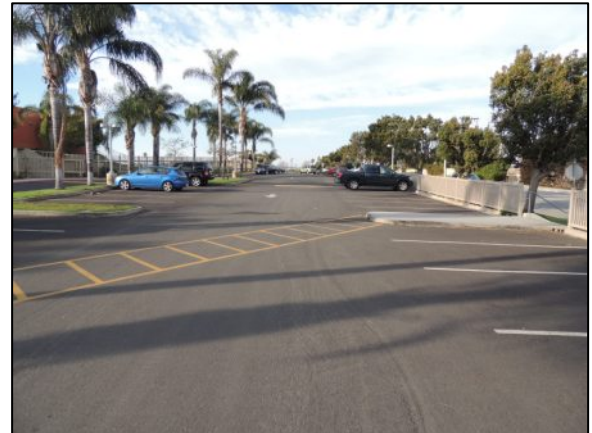
- The property does not have a dedicated paving repair and maintenance contractor. On-site personnel maintain the paving and flatwork or a contractor is retained when required.

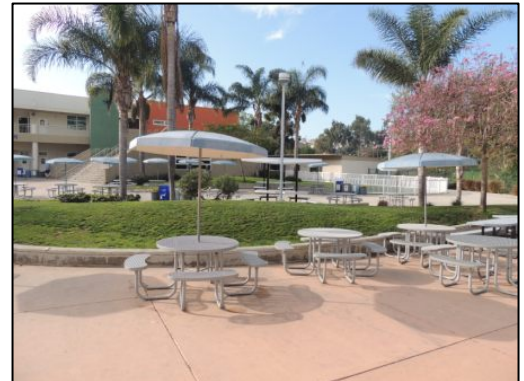
- The topography and adjacent uses do not appear to present conditions detrimental to the property.
- The landscape materials are in good condition and will require routine maintenance during the assessment period.
- The underground irrigation system appears to be in good working order. Replacement of sprinkler heads and minor repairs will be required during the assessment period. This work is considered to be routine maintenance.
- The retaining walls are in good condition. Routine maintenance will be required during the assessment period.

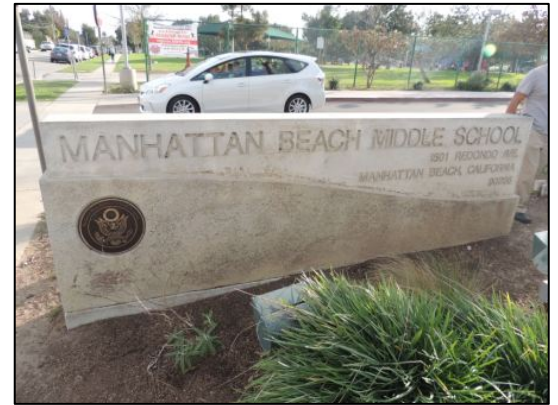
- The property and tenant identification signs are in good condition. Routine maintenance will be required during the assessment period.
- The exterior site and building light fixtures are in good condition. Routine maintenance will be required during the assessment period.
- The site fencing is in good condition and will require routine maintenance during the assessment period. Scraping and painting is considered to be routine maintenance.
- The dumpsters are owned and maintained by the refuse contractor. The dumpster enclosures, slabs, and gates are in good condition and will require routine maintenance during the assessment period.

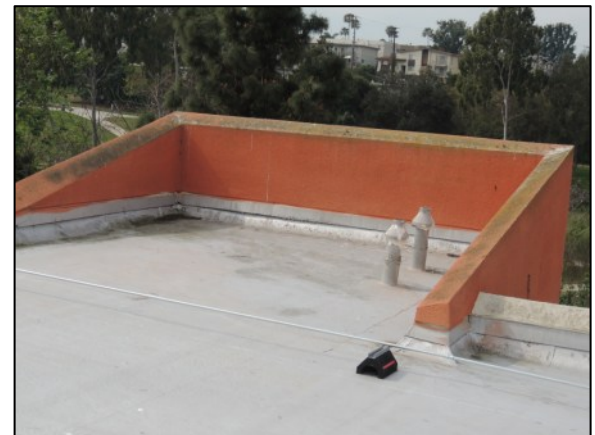
- The property does not have a dedicated roof repair and maintenance contractor. On-site personnel maintain the roofs or a contractor is retained when required.

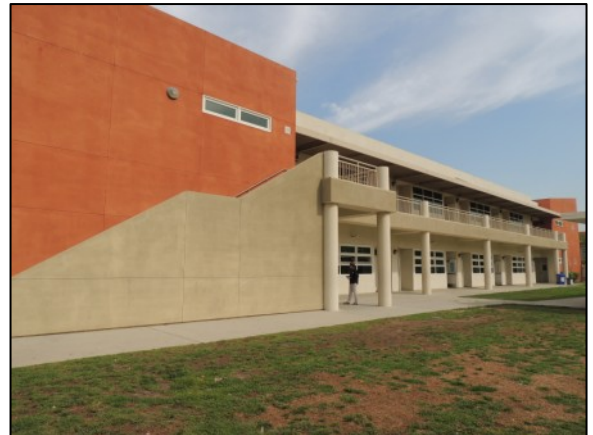
- The exterior finishes are in good condition. Painting and patching will be required during the assessment period. The cost of this work is included in the Replacement Reserves Report.
- The curtain wall system is in good condition. Based on its estimated Remaining Useful Life (RUL), the curtain wall's sealant system will require replacement during the assessment period. The cost of this work is included in the Replacement Reserves Report.
- The sealant is flexible, smooth, and in good condition and will require routine maintenance during the assessment period.

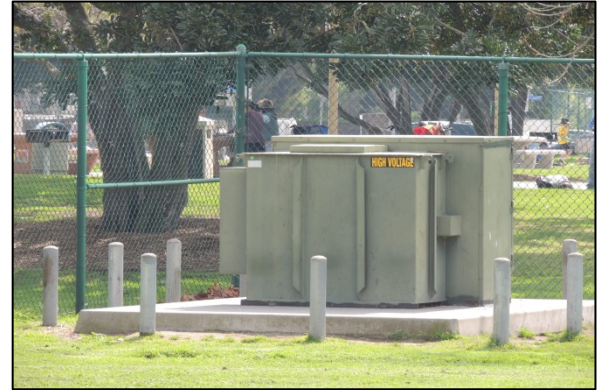
- The on-site electrical systems up to the meter are owned and maintained by the respective utility company.
- The electrical service and capacity appear to be adequate for the property's demands.
- The switchgear, circuit breaker panels, and electrical meters appear to be in good condition and will require routine maintenance during the assessment period.
- The three smaller transformers at each of the buildings are in good condition. Based on their estimated Remaining Useful Life (RUL), replacement is recommended during the reserve term. The estimated cost for this work is included in the Replacement Reserves Report.

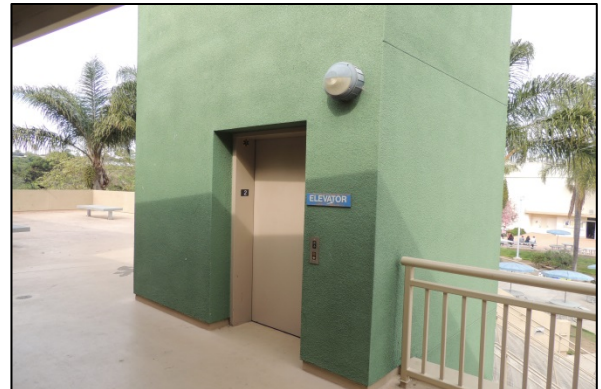
- The elevators are serviced by Dover Elevators on a routine basis. The elevator machinery and controls are the originally installed system.
- The elevators appear to provide adequate service. Based on its estimated Remaining Useful Life (RUL), the elevator equipment will require replacement during the assessment period. The cost of this work is included in the Replacement Reserves Report.

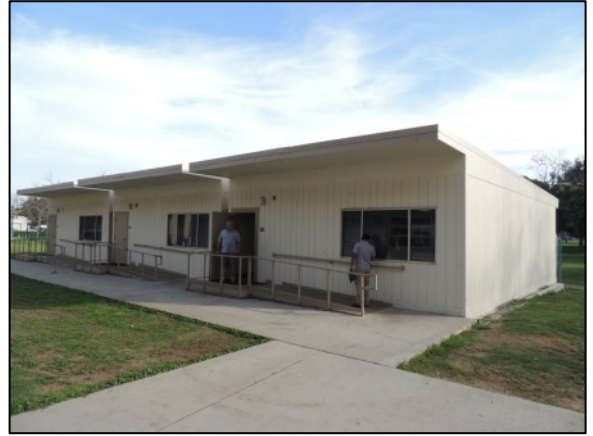
- The modular classrooms are in good to fair condition and will require routine maintenance during the assessment period.
- The maintenance and storage sheds are in good to fair condition and will require routine maintenance during the assessment period.
