FACILITY CONDITION ASSESSMENT

FACILITY CONDITION ASSESSMENT of

GRAND VIEW ELEMENTARY

EMG Project #: 112851.15R-004.017
Date of Report: April 13, 2015
On site Date: February 17, 2015

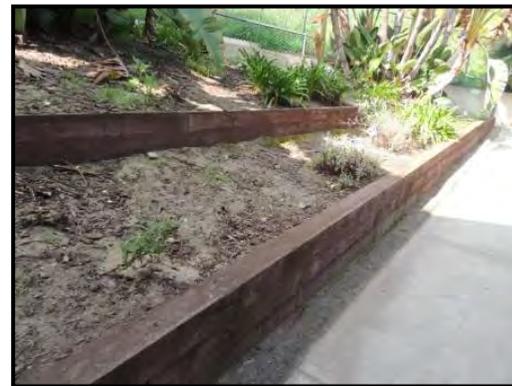
- The topography and adjacent uses do not appear to present conditions detrimental to the property.
- The landscape materials are in fair condition and will require routine maintenance during the assessment period.
- The underground irrigation system appears to be in good working order. Replacement of sprinkler heads and minor repairs will be required during the assessment period. This work is considered to be routine maintenance.
- The retaining walls are in good to fair condition. Routine maintenance will be required during the assessment period.

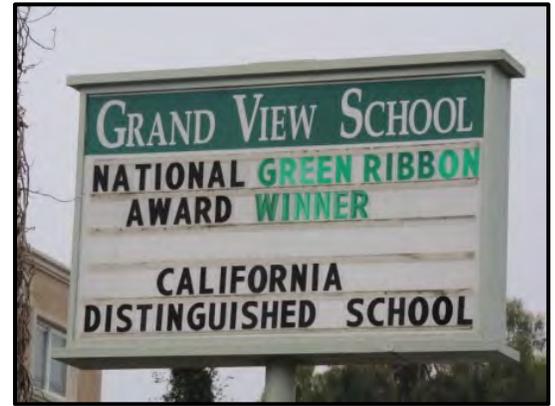
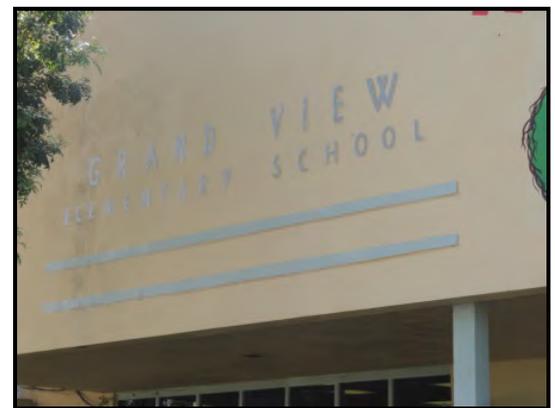
- The property identification signs are in good condition. Routine maintenance will be required during the assessment period.
- The exterior site and building light fixtures are in good condition at the Grand View Campus and in fair condition at the Ladera Campus. Routine maintenance will be required during the assessment period.
- The site fencing is good to fair condition at the Grand View Campus and in fair condition at the Ladera Campus and will require routine maintenance during the assessment period.
- At both, the dumpsters are owned and maintained by the refuse contractor. At the Grand View Campus, the dumpster enclosures, slabs, and gates are in good condition and will require routine maintenance during the assessment period.

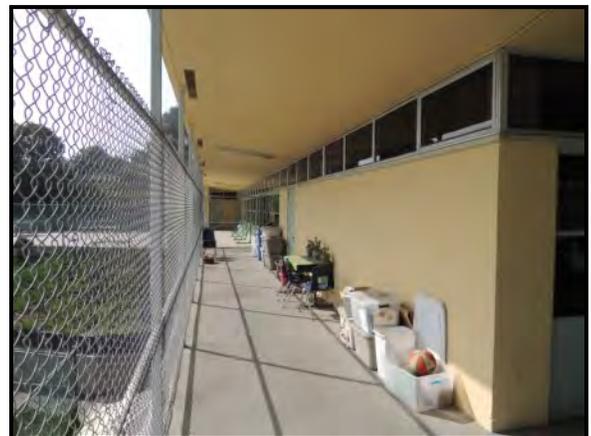
- The exterior finishes are in fair condition. Painting and patching will be required during the assessment period. At the Grand View Campus, painting and patching of the covered walkways will be required during the assessment period. The cost of this work is included in the Replacement Reserves Report.

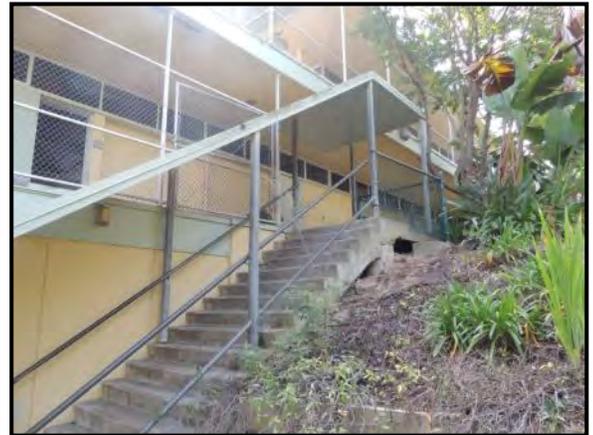
- At the Grand View Campus, the exterior stairs, balusters, and handrails are in good to fair condition. Several areas have shown failure. See Section 1.2.
- At the Ladera Campus, the exterior stairs, balusters, and handrails are in fair to poor condition. The exterior stairs shall be reviewed as part of the ADA study noted in Section 3.2, reviewed as part of the drainage and structural studies noted in Section 1.2.

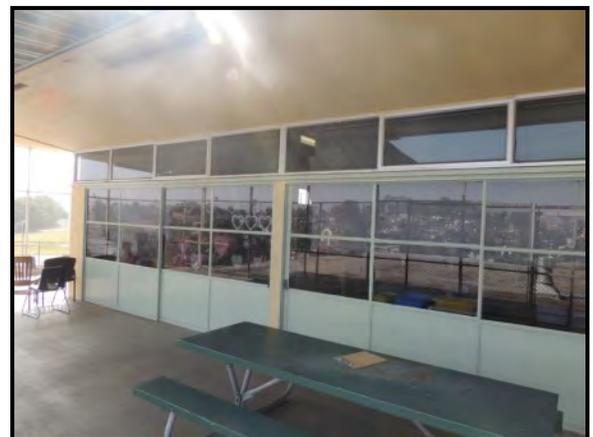
- There is no evidence of window leaks or window condensation. The windows are in fair condition and will require routine maintenance during the assessment period.
- The exterior doors and door hardware are in fair condition and will require routine maintenance during the assessment period.
- The exterior sliding doors and hardware are in fair condition being that they are generally difficult to open. The sliding doors will require routine maintenance during the assessment period.

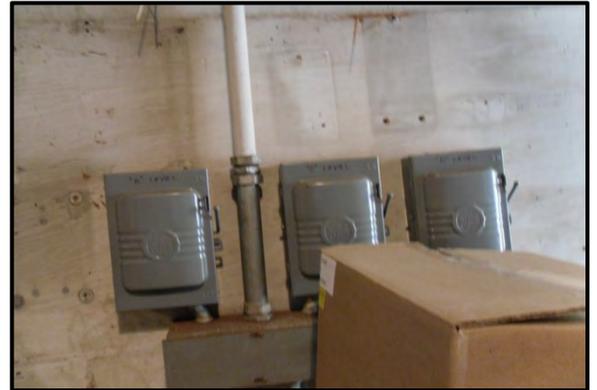
- The on site electrical systems up to the meter are owned and maintained by the respective utility company.
- The electrical service and capacity appear to be adequate for the property's demands.
- At the Grand View Campus, the exterior panels housing the switchgear and electrical meters are showing substantial deterioration and rust. Some of these panels will need to be replaced. The cost of this work is included in the Short Term Cost report.
- At the Ladera Campus, the electrical distribution system and exterior panels housing the switchgear are in poor condition and will need to be replaced. The cost of this work is included in the Short Term Cost report.

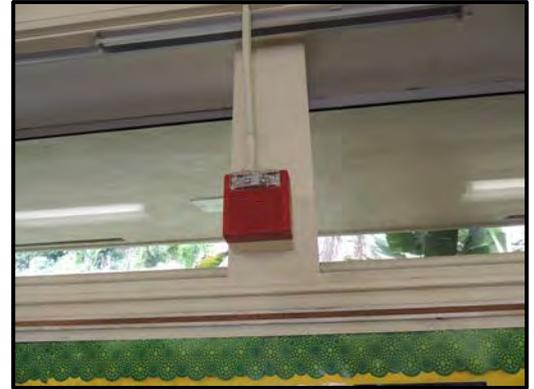
- Information regarding fire department inspections is included in Section 3.1.
- The pull stations and alarm horns appear to be in good condition and will require routine maintenance during the assessment period.

- Smoke detector replacement is considered to be routine maintenance.
- Exit sign replacement is considered to be routine maintenance.
- The central alarm panel appears to be in good condition and is serviced regularly by a qualified fire equipment contractor. Equipment testing is not within the scope of a Facility Condition Assessment. Based on inspection documents displayed by the panel, the central alarm panel has been inspected within the last year. Fire alarm panels contain sophisticated electronic circuits that are constantly energized. Over time, circuit components deteriorate or become obsolete. Even though an alarm panel may continue to function well past its estimated design life, replacement parts may become difficult to obtain and in many cases the alarm panel will not communicate with new devices it is supposed to monitor. Based on its estimated Remaining Useful Life (RUL), replacement is recommended during the reserve term. The estimated cost of this work is included in the Replacement Reserves Report. Note that replacement of a fire alarm panel or other components may trigger a requirement to update to a fully automatic system to comply with current codes.

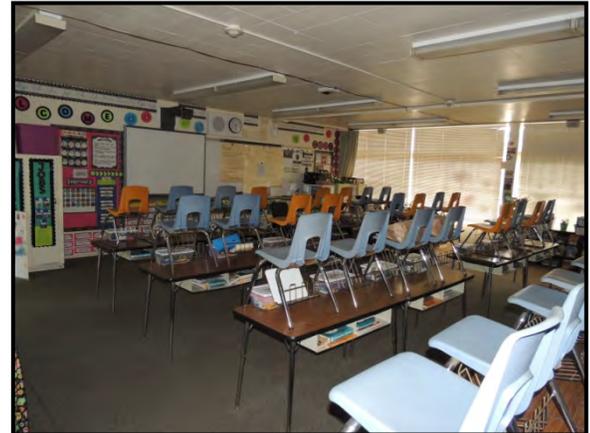
- The interior finishes are in good to fair condition at the Grand View Campus and in fair condition at the Ladera Campus. Replacement of the floor finishes and painting will be required during the assessment period. The cost of this work is included in the Replacement Reserves Report.
- The interior doors and door hardware are in fair condition and will require routine maintenance during the assessment period.

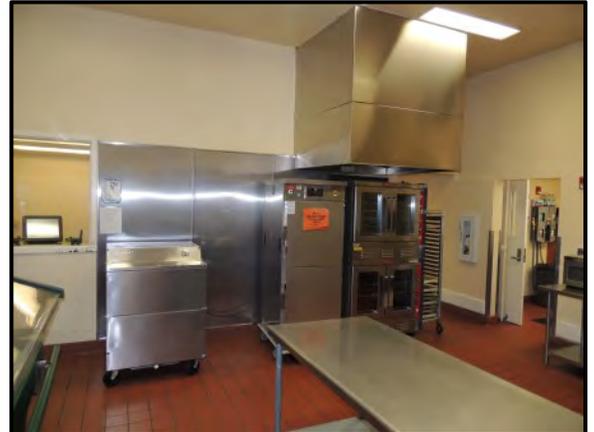
The kitchen appliances appear to be in good to fair condition. Based on their estimated Remaining Useful Life (RUL) the equipment will need to be replaced during the assessment period. The cost for this work is included in the Replacement Reserves Report.

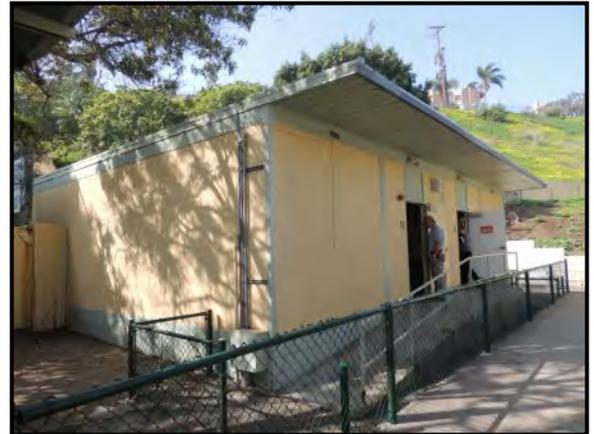
- The modular buildings are in fair to poor condition, the roofing and siding are exhibiting signs of deterioration. See Section 1.2.
- The maintenance and storage building is in good condition and will require routine maintenance during the assessment period

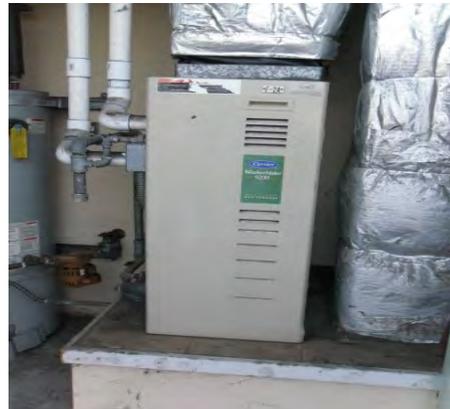
Photo #46:	Gas furnace in mechanical closet
------------	----------------------------------

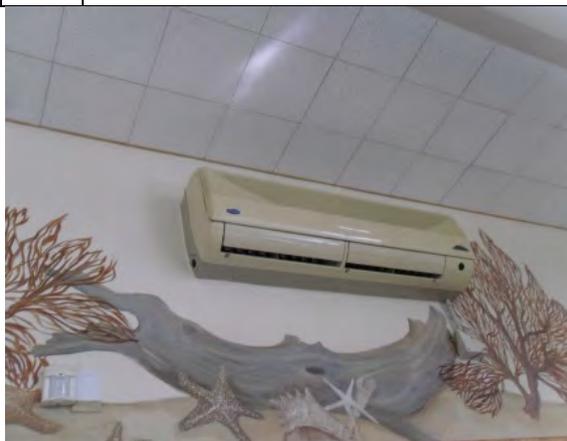
Photo #47:	Split air conditioner unit
------------	----------------------------

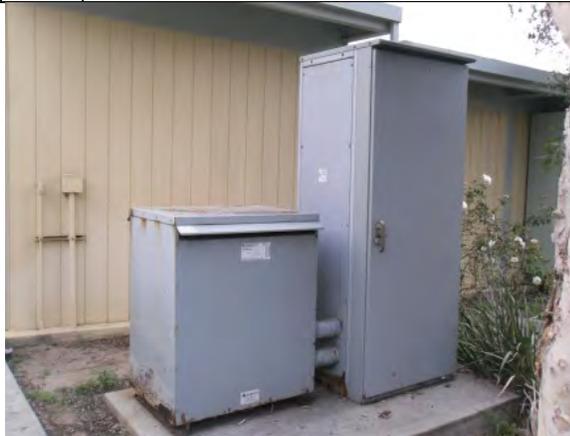
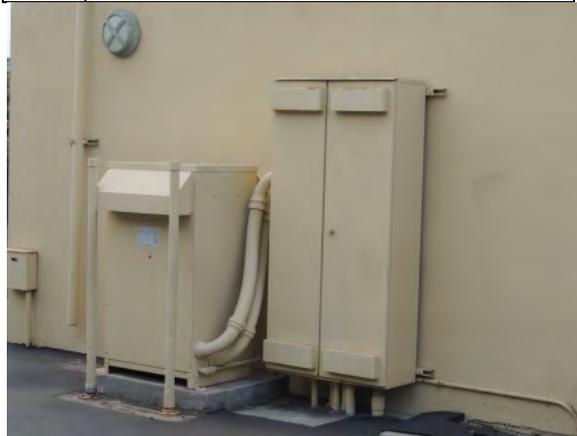
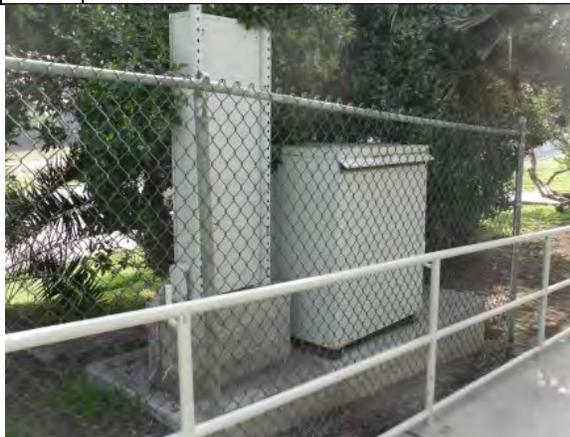
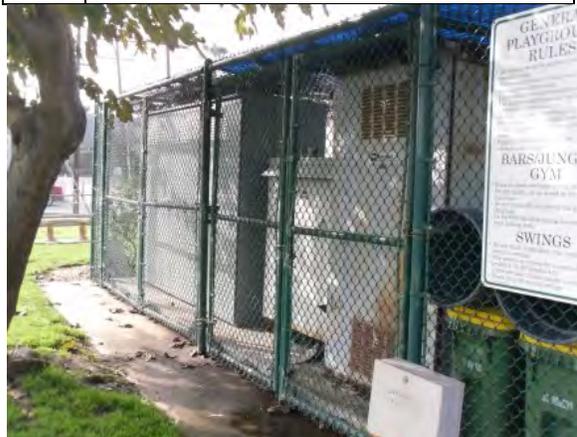
Photo #51: Transformer and electrical panels

Photo #52: Transformer and electrical panels

Photo #53: Transformer and electrical panels

Photo #54: Transformer and electrical panels

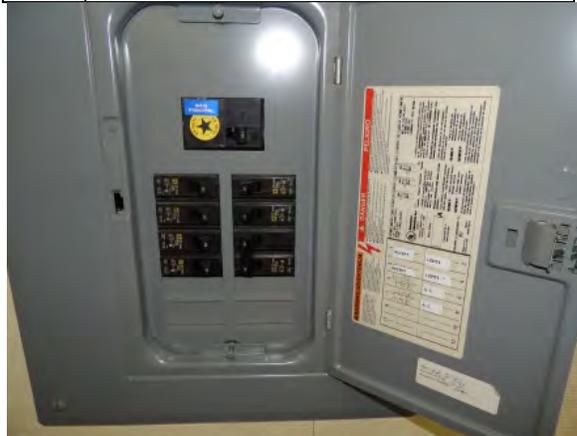
Photo #58: Typical portable classroom electrical panel

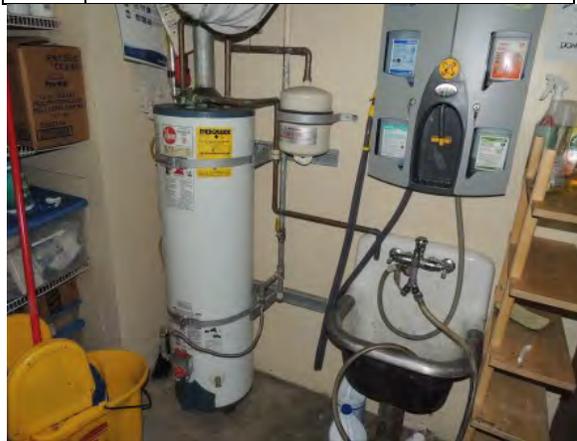
- The classroom accessories and fixtures are in good condition. These components will require routine maintenance.
- The pressure and quantity of hot water appear to be adequate.
- The gas water heaters appear to be in good condition. Based on the estimated Remaining Useful Life (RUL), the water heaters will require replacement during the assessment period. The cost of this work is included in the Replacement Reserves Report.

Photo #64: Typical water heater

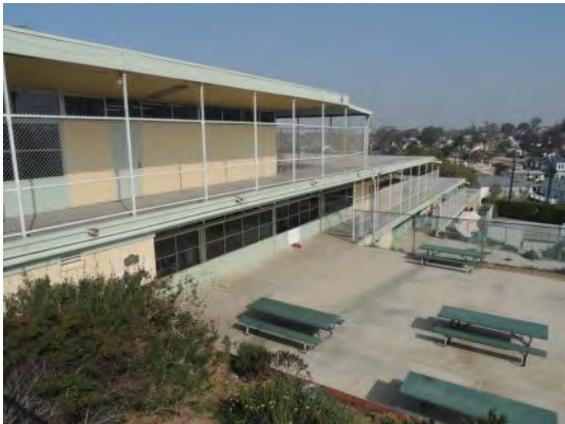
Photo #3: Tiered classroom wing

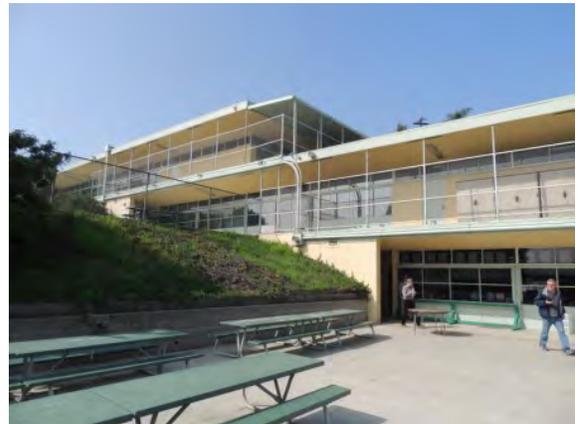
Photo #4: Tiered classroom wing

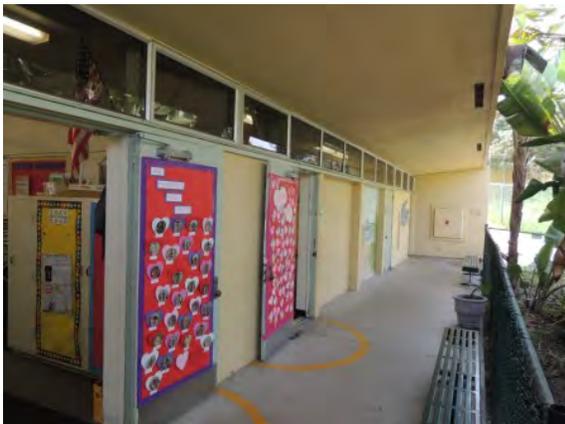
Photo #5: Classroom entrances

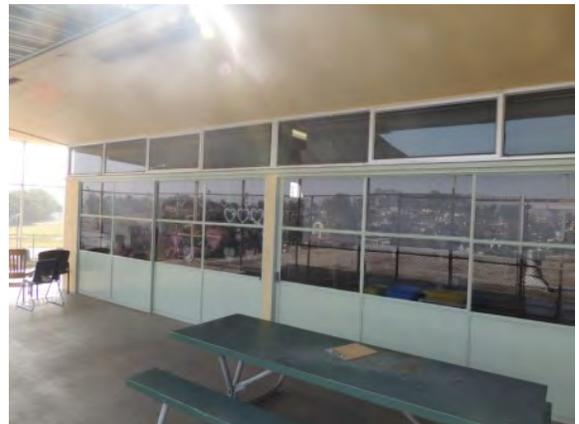
Photo #6: Classroom sliding doors

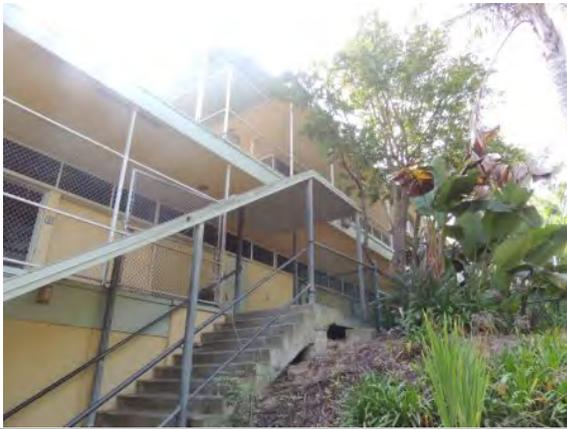
Photo #7:	Classroom stairs
-----------	------------------

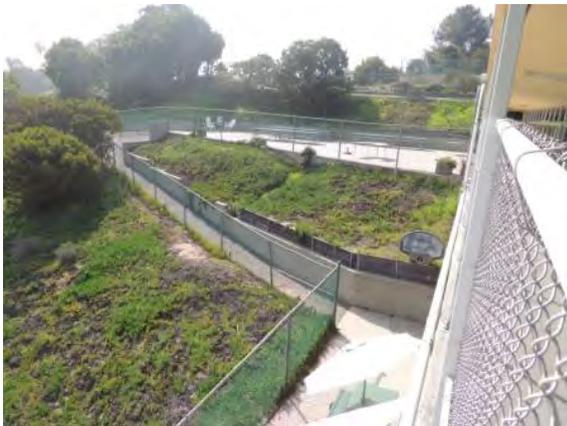
Photo #9:	Sloped walkway up to classrooms
-----------	---------------------------------

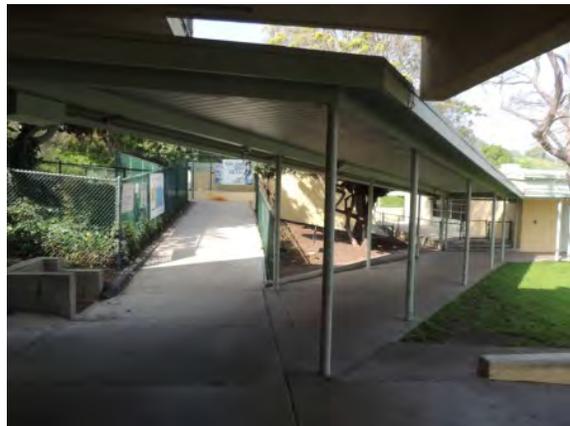
Photo #10:	Covered walkway
------------	-----------------

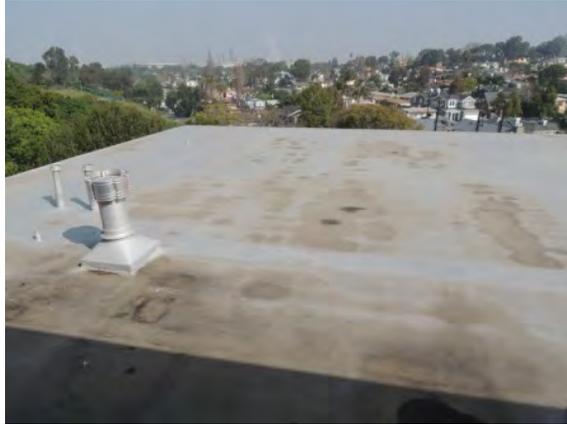
Photo #19:	Roofing
------------	---------

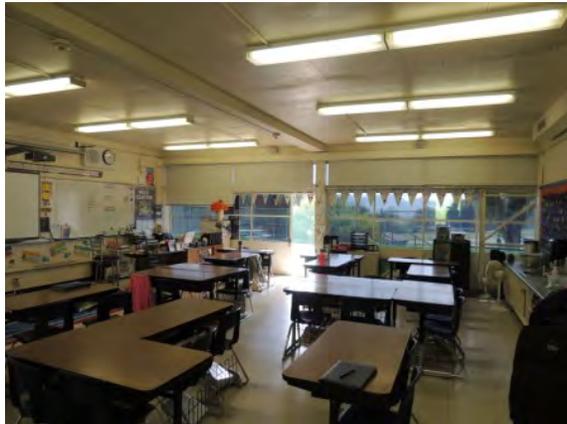
Photo #21:	Classroom
------------	-----------

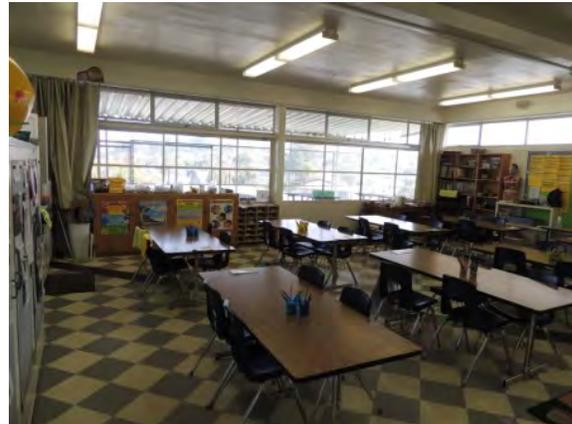
Photo #22:	Classroom
------------	-----------

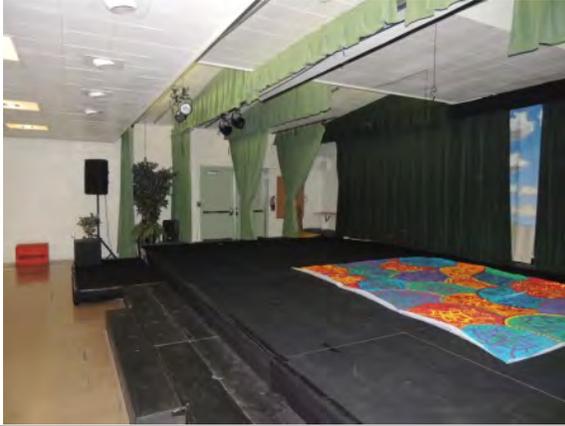
Photo #25:	Performing arts center
------------	------------------------

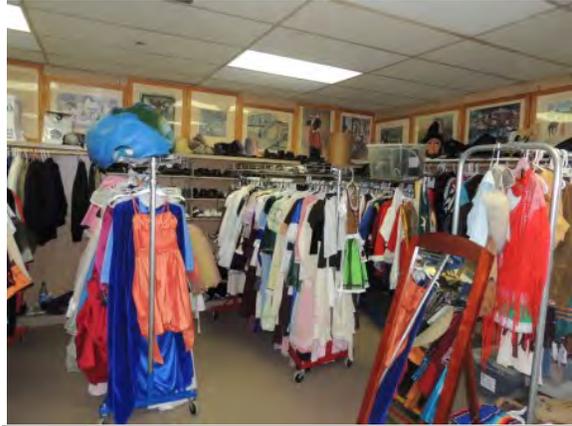
Photo #26:	Costume storage
------------	-----------------

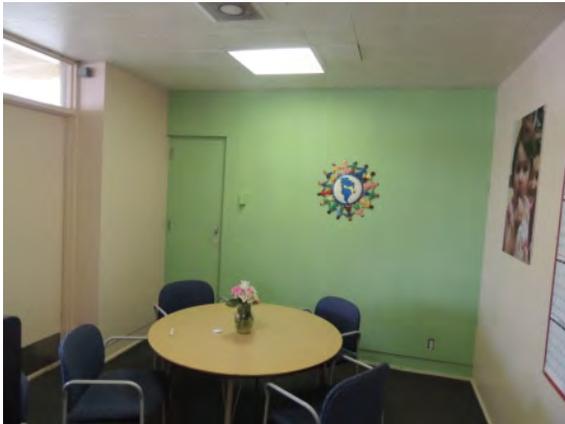
Photo #27:	Office area
------------	-------------

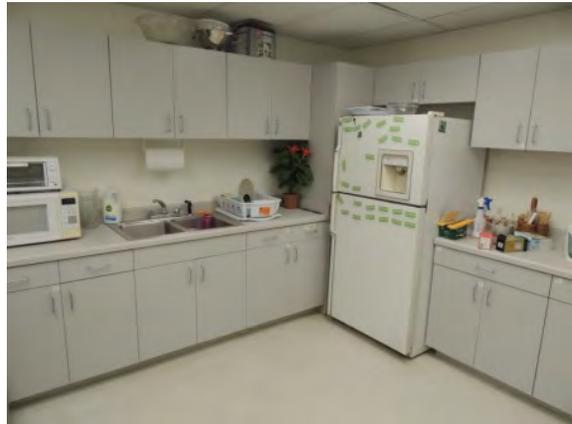
Photo #28:	Break room
------------	------------

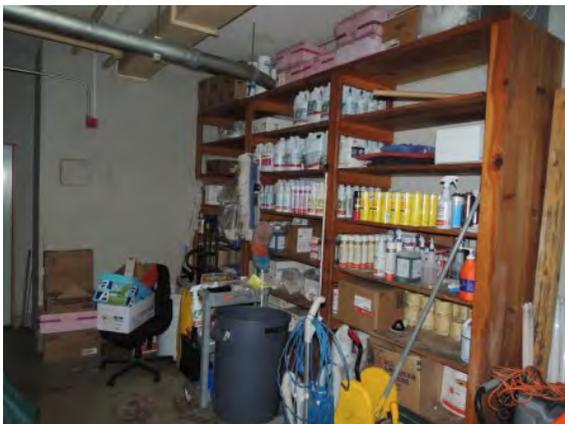
Photo #29:	Storage room
------------	--------------

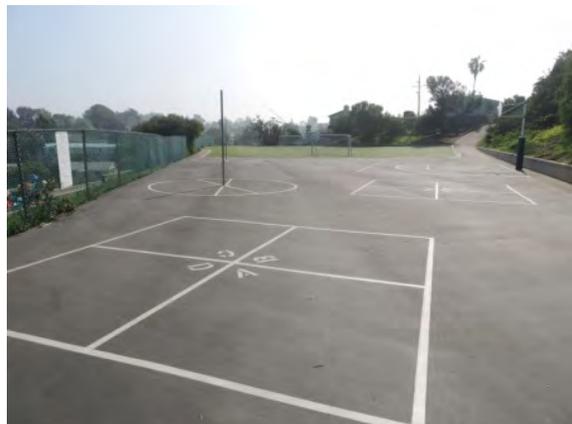
Photo #30:	New playground area
------------	---------------------

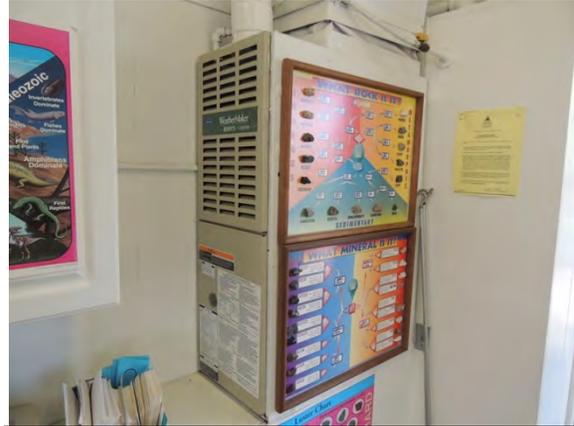
Photo #32: Typical classroom furnace

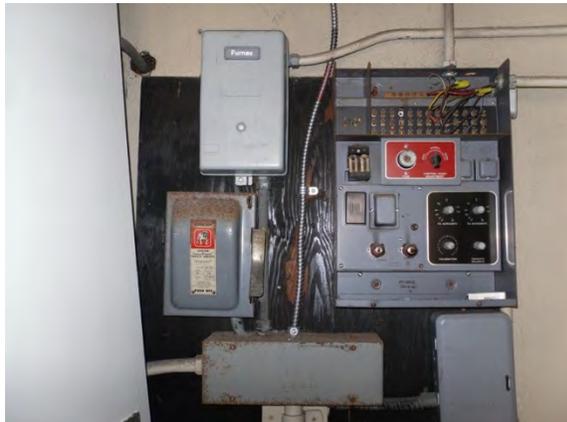
Photo #33: Performing arts furnace controls

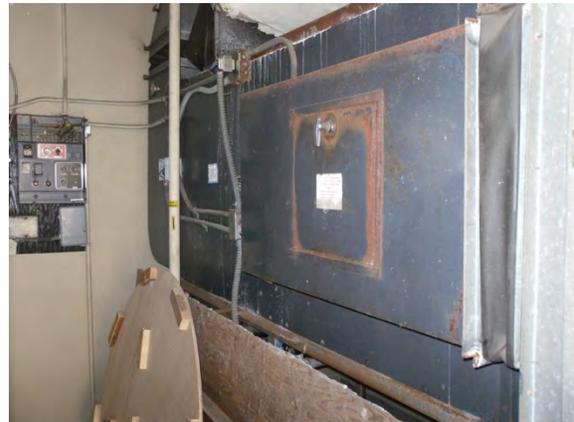
Photo #34: Performing arts furnace

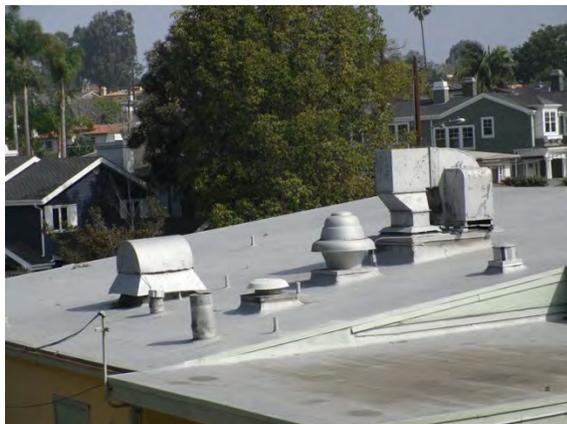
Photo #35: Performing arts rooftop equipment

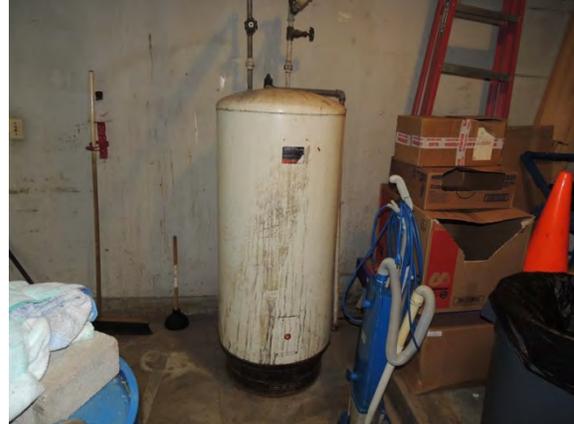
Photo #36: Expansion tank

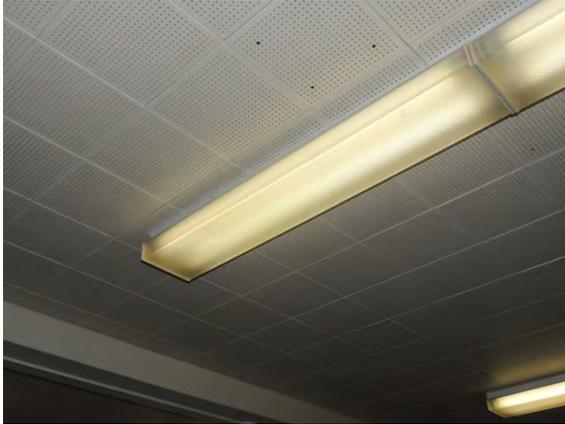
Photo #37: Typical classroom lighting

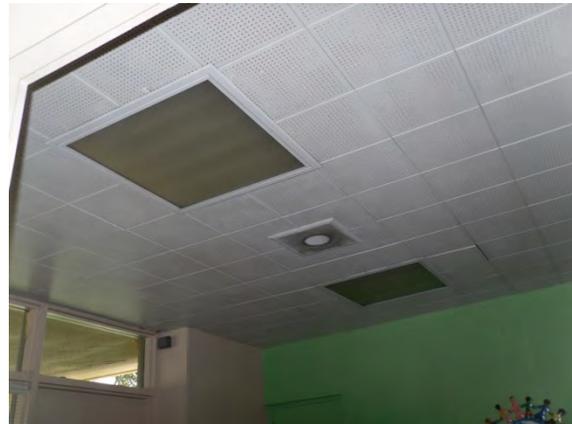
Photo #38: Office lighting

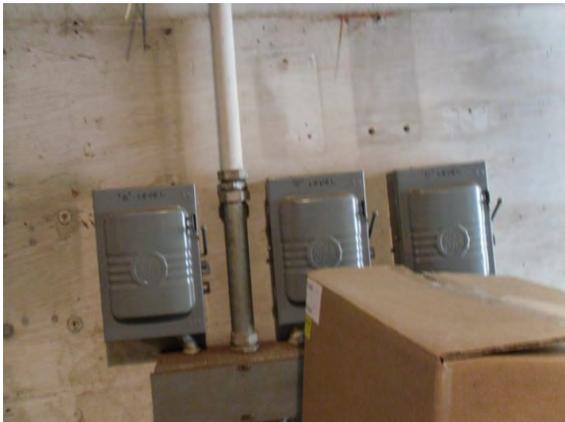
Photo #39: Electrical equipment

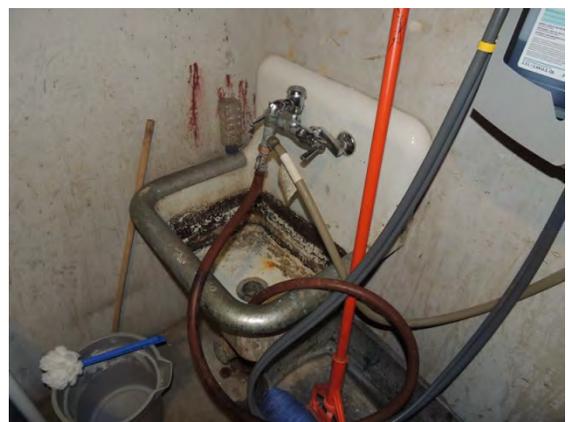
Photo #40: Janitor room sink

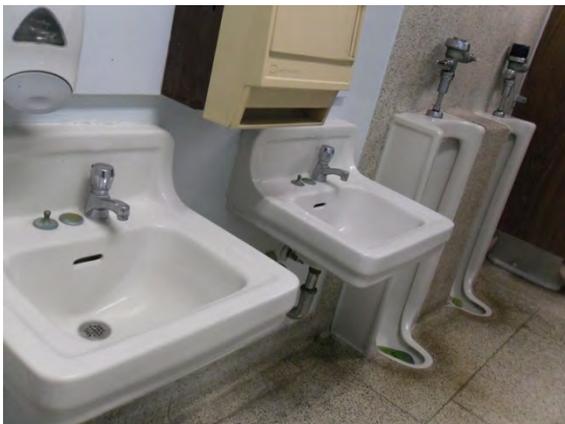
Photo #41: Typical bathroom fixtures

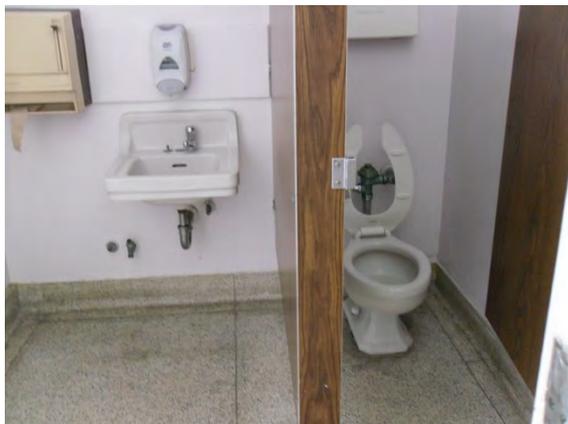
Photo #42: Typical bathroom fixtures
